Drinking Water Long-Term Monitoring Comprehensive Report

JOINT BASE PEARL HARBOR-HICKAM, O'AHU HI

2025 Revision

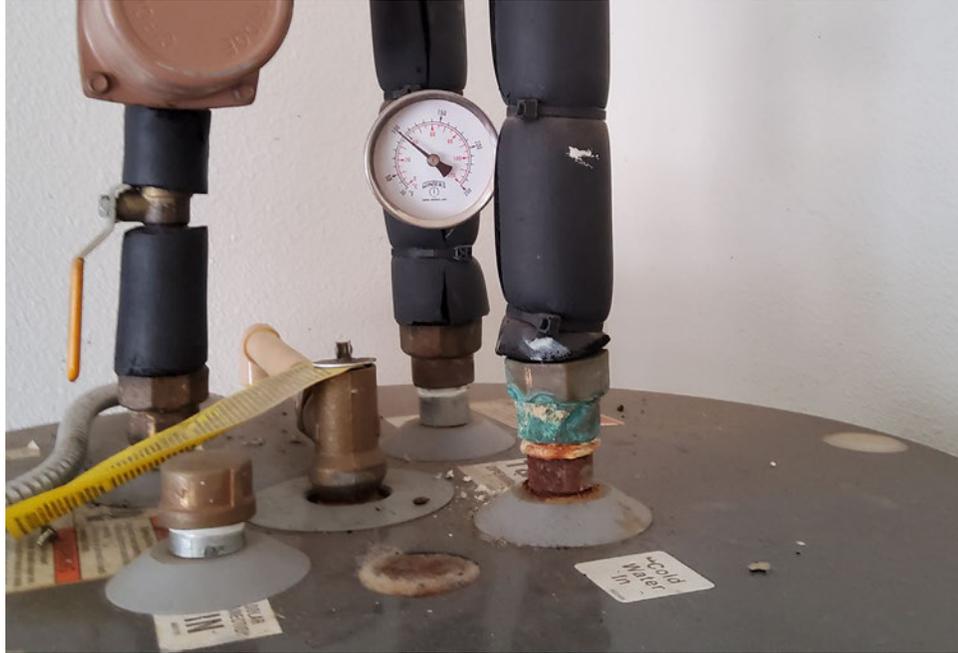
Figure 3. Water Heater at 2110 Schmitt Parkway.

- The temperature gauge installed on the hot water discharge pipe indicated only 100°F.
- No other water quality measurements were taken during this visit.

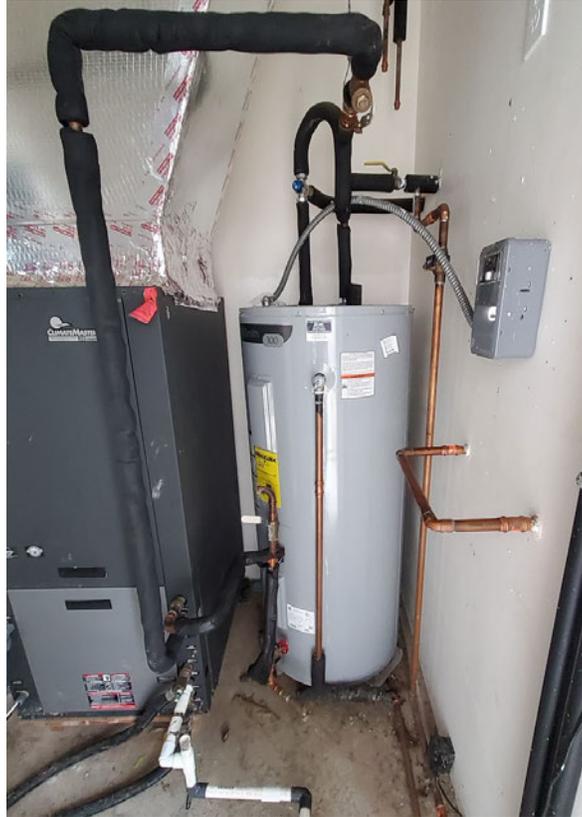
Figure 4. Water Heater and AC Unit at 6343 Papaya Lane.

- The inspector checked the cold water in the upstairs bathroom and detected a metallic taste and odor, which might resemble “pond” water. The taste and odor disappeared after a few seconds of flushing.
- The hot water temperature at the kitchen sink was only 108°F.
- The water heater was made by AO Smith (Model Signature 100), and it appeared to be a newer model (year, serial was not noted). The heater is no longer connected to solar roof panels but has recently been plumbed to receive waste heat from the adjacent air conditioning unit. The pipe material is copper. A thermostatic mixing valve was installed between the cold supply and hot water line (Figure 4).
- The chlorine residual at the upstairs master bathroom sink was acceptable (0.28 mg/L). Iron was not detectable (< 0.10 mg/L).

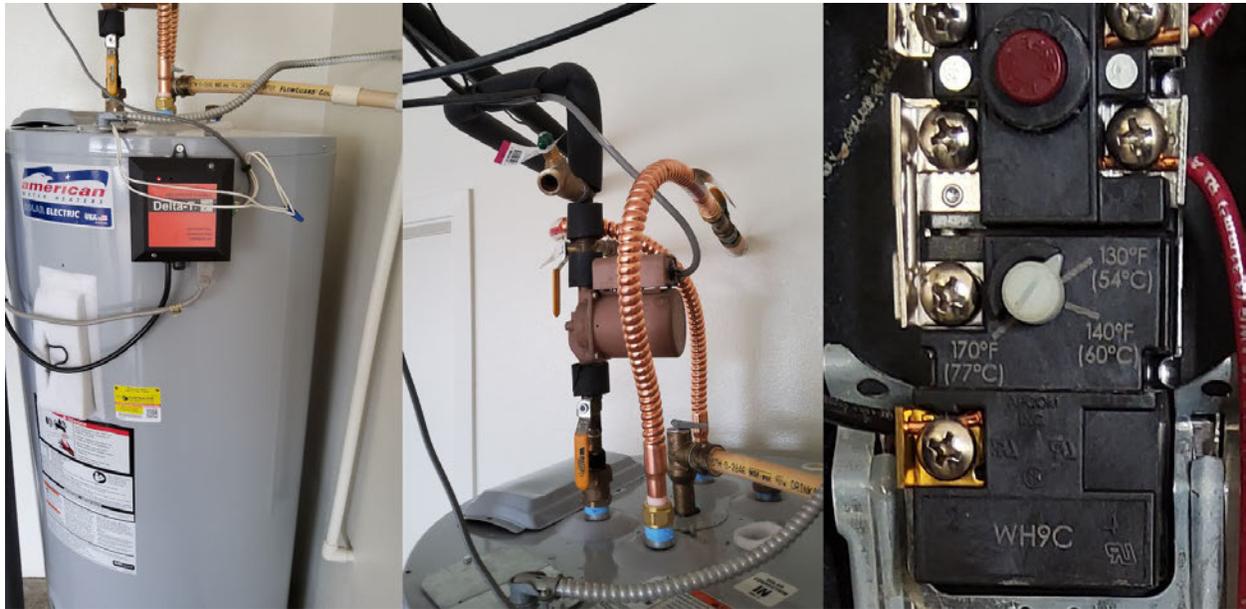
Figure 8. Water Heater at 2879 Arizona Road.

- The PPV plumbers removed the cover from the heating element panel. The temperature setting of the heater was approximately 125°F (Figure 8).
- The inspector withdrew approximately 50 mL of water from the heater's drain valve. The initial aliquot had no chlorine residual, was turbid, and had a bluish hue. This was likely due to the water stagnating in the brass fittings and valve. The water cleared with the next aliquot.

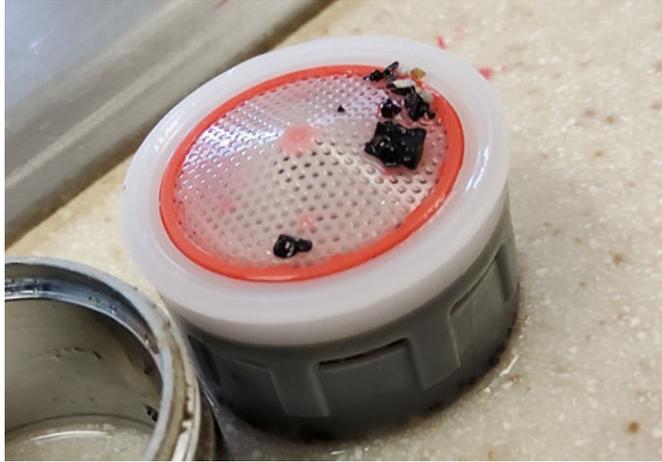
Close inspection of the aerator that was removed from the kitchen faucet revealed the presence of two sand grains as well as a few small, brittle, black particles (Figure 9). The origin of the materials is uncertain. However, replacement of water service lines made from polyethylene was ongoing in the area, which could have resulted in plastic debris entering the water system.

Figure 9. Particulate Matter on Kitchen Faucet Aerator.

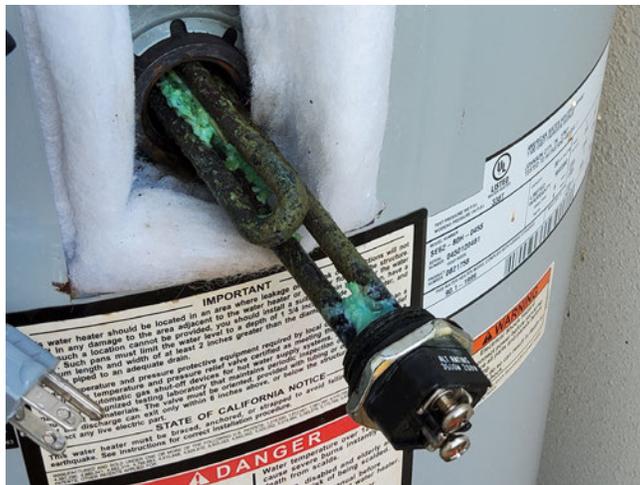
be expected even in soft to moderately hard water (Figure 10). The appearance and white/green coloration of the scale suggests precipitates of calcium carbonate, cupric salts, and potentially, magnesium hydroxides. The heating element was retained in a re-sealable bag filled with water drained from the tank.

Figure 10. Heating Element and Mineral Scales.

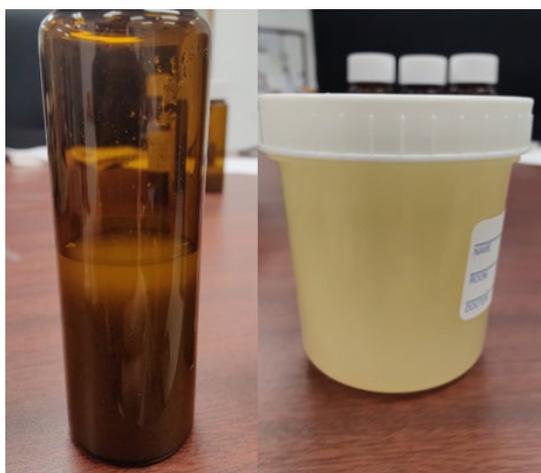
After the tank had drained completely, the plumbers laid the heater on its side to remove the anode rod. This required considerable force, resulting in the rod shearing off from the tightening nut and falling into the tank vessel. Through the two openings in the tank, the plastic dip tubes were visible and appeared intact, but further inspection required a larger opening. Public Works (PW) personnel transported the heater to a warehouse for later inspection. At the warehouse the personnel drained the remaining water from the tank and captured several aliquots, which appeared to contain appreciable amounts of sand and some gelatinous materials, likely hydroxides of magnesium and silica. The material was retained in amber 40-mL glass vials. The turbid supernatant was poured into a small plastic specimen container (Figure 11).

Figure 11. Solids and Liquid Removed from Bottom of Water Heater

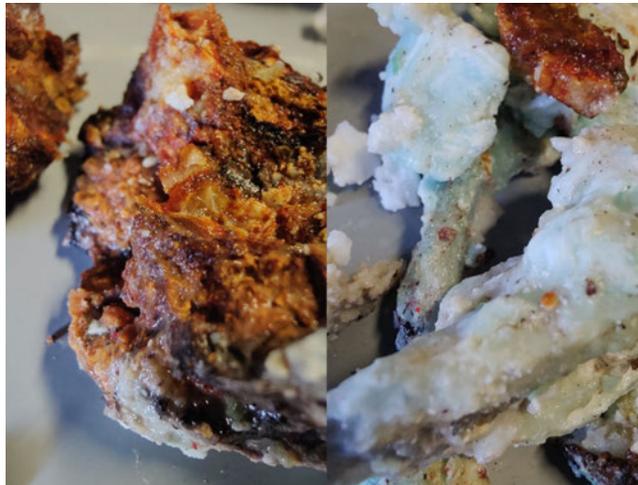
In summary, the tank appeared to be in a condition commensurate with its age and the apparent lack of maintenance. There was a considerable accumulation of sand in the tank, suggesting that it has not been flushed annually. The accumulated sand has the potential to harbor microorganisms, particularly if adequate water temperatures and/or chlorine residuals are not maintained. The anode rod was completely corroded, which is likely the reason for the onset of corrosion of the steel shell. The recommended replacement interval for anode rods is 3 to 5 years.

Figure 12. Corroded Anode Rod Parts and Mineral Scale

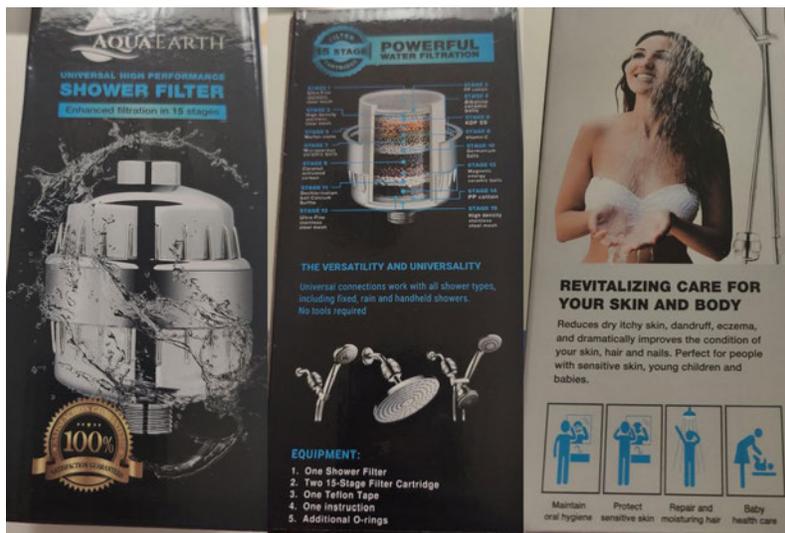
Figure 14. Shower Filter at 5202 Fuqua Lane.

- The resident utilizes an AquaEarth shower filter (Figure 14). The device is not NSF-certified for the claimed water treatment effects⁶.

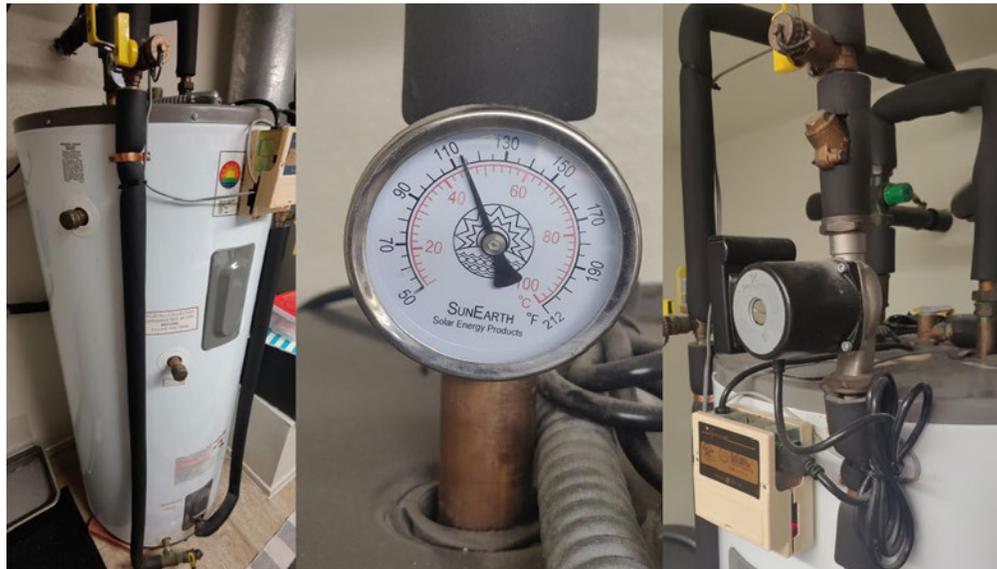
Figure 16. Solar Water Heater at 5202 Fuqua Lane.

- The thermometer installed at the discharge piping from water heater, upstream of the thermostatic mixing valve, indicated 114°F, which is below the minimum value recommended by ASHRAE (Figure 16).

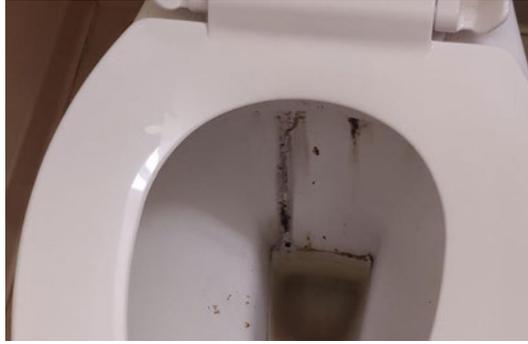
Figure 25. Black Residue in the Toilet Bowl.

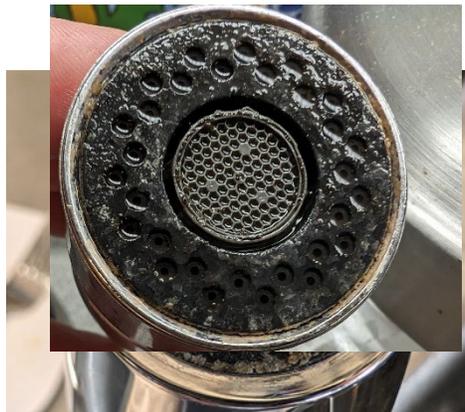
-
- Found mineral scale on one bathroom faucet aerator, and a small particle on another.

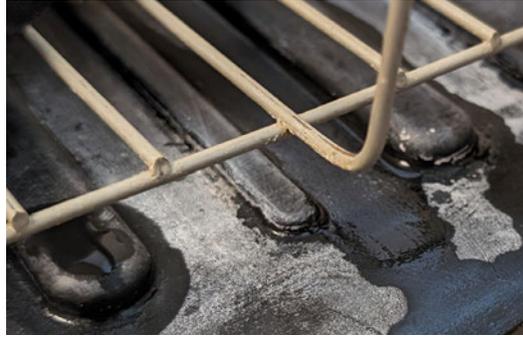
- Observed calcite buildup on most outlets.

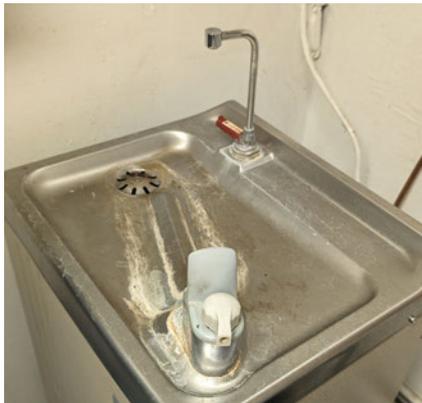
- There was a massive accumulation of rust and mineral particles on the bathroom faucet aerator. Advised tenant to have aerator replaced.

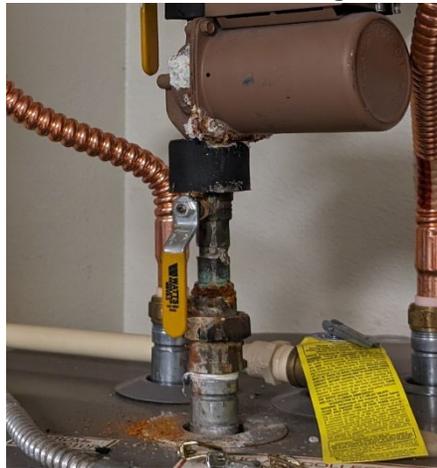
- Resident stated that the automatic timer has been disabled to ensure availability of hot water throughout the day. The solar water recirculation loop is not isolated, and the thermostat and the pump were both plugged in.

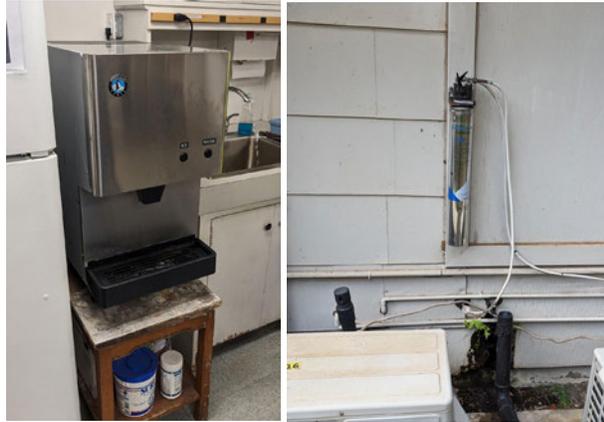
- The filter (Pentair Everpure i20002, EV9612-22) is installed on the outside wall of the building, exposed to the elements. The filter has last been replaced in May of 2023.

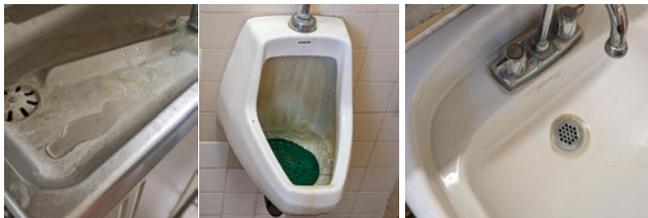
- The faucet aerator in kitchen was clean, but aerators on four faucets in the bathroom presented significant buildup of debris resembling dirt and rust. The particulate matter may be a result of the recent service line repair or could be due to interior corrosion of the water heater.
