Joint Base Pearl Harbor-Hickam (JBPHH) Public Water System No. HI00000360 & Aliamanu Military Reservation (AMR) Public Water System No. HI0000337

Extended Drinking Water Monitoring Plan: First Quarterly Report

Sampling Results Report for the JBPHH System (April – June 2024)

21 July 2025

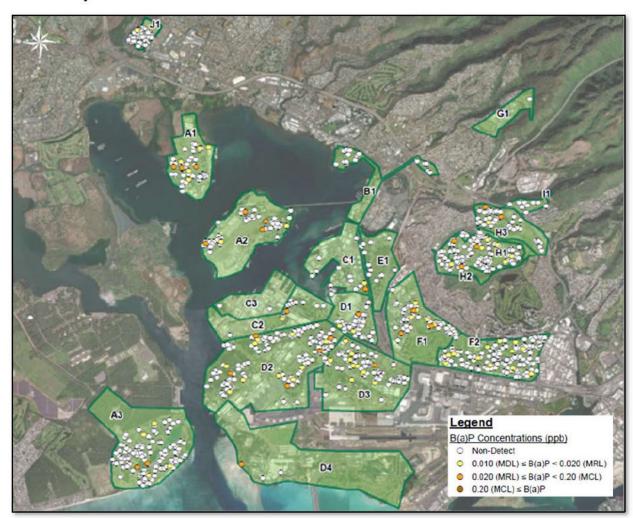
Figure 4. First Quarter (April - June 2024) EDWM Benzo(a)pyrene Sampling Results

The detections were observed throughout the System and are not limited to one Zone or general area. Detections of benzo(a)pyrene are surrounded by non-detects and do not indicate there is a system-wide impact or source. TPHs were not detected at all locations where benzo(a)pyrene was detected, with one exception in Zone D2 (i.e., Hydrant 236; Field Sample ID No. D2-DL-0017711- 24092-N). A Tier 2 analysis was performed at this location and the results of that evaluation concluded JP-5 or other fuel-related analytes were not impacting that location (see Section 3.2 for more information). The Navy will continue to monitor benzo(a)pyrene concentrations in the System and investigate the cause or source of these detections. The results of this investigation will be documented in a technical memorandum and submitted to EPA/State of Hawaii, Department of Health (DOH) for review and discussion.

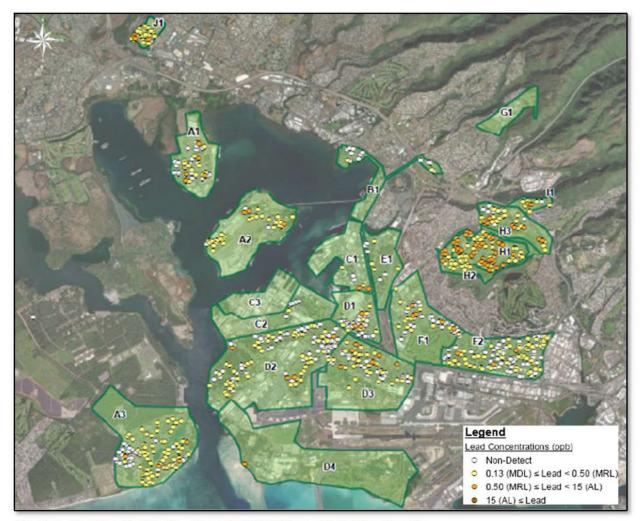
Figure 5. First Quarter (April - June 2024) EDWM Lead Sampling Results

Lead was not detected in a pre-chlorination sample collected from Waiawa Shaft (source water) on 03 June 2024. Lead was detected at 0.16 ppb in a post-chlorination sample collected from Waiawa Shaft (source water) on 03 June 2024. Lead was not detected in the samples collected in 2023 as part of the JBPHH compliance monitoring program. The detections were observed throughout the System and are not limited to one Zone or general area. Lead in the System is likely associated with premise plumbing.

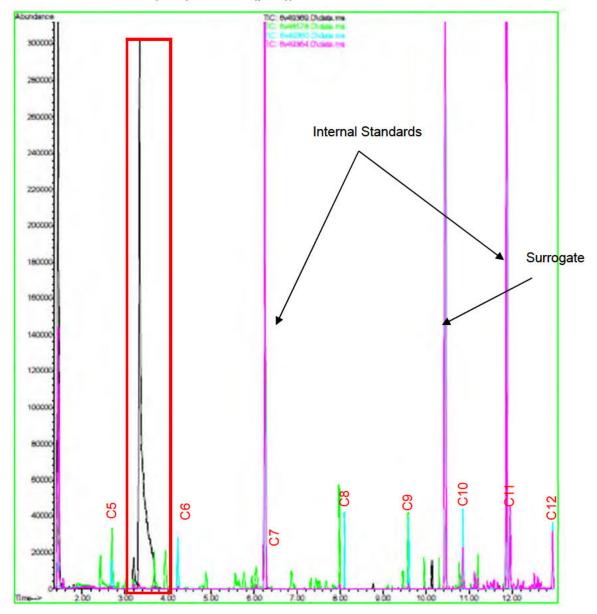
Figure 2. D2-DL-0017717-24122-N (Overlayed with a gasoline calibration standard (green), retention time marker (blue) and JP-5 (pink)).

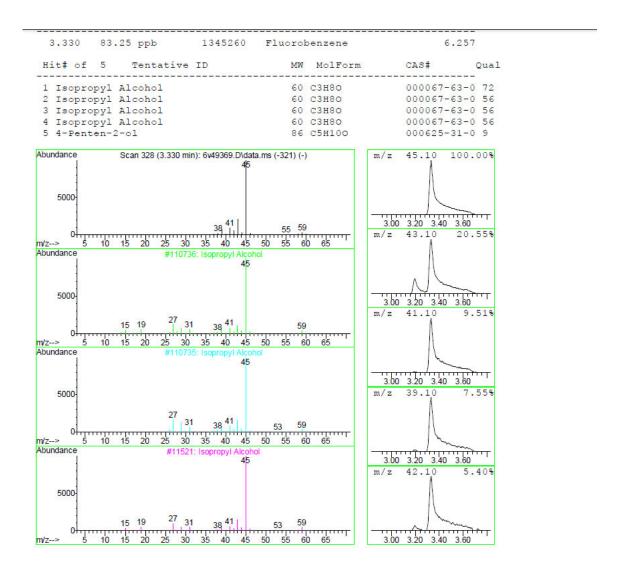
Because GC/MS methods like 8260 allow for the evaluation of mass spectra leading to identification, the laboratory was able to conduct a Tier 1 analysis simultaneously. The mass spectrum is provided in Figure 3 and identifies the peak as isopropyl alcohol. The tailing peak shape, early RT, and mass spectrum are all consistent with isopropyl alcohol.

Figure 3. D2-DL-0017717-24122-N (8260 Mass Spectral Analysis)

AECOM's standard operating procedure (SOP) for hydrant sampling specifies decontamination of the hydrant spigot fitting with isopropyl alcohol, followed by rinsing with deionized (DI) water prior to purging and sampling. The DI rinse and purging should have eliminated any traces of isopropyl alcohol, but it is possible that the rinsing was incomplete or that the isopropyl alcohol came into contact with another piece of equipment or the sampler's glove and was introduced into the sample.

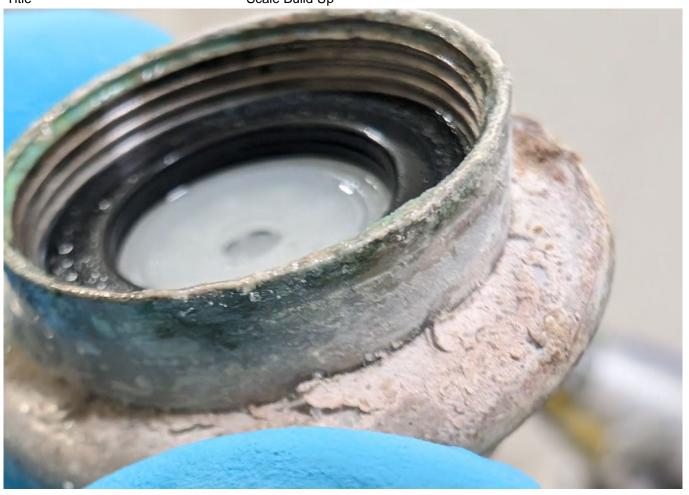
Title Scale Build Up

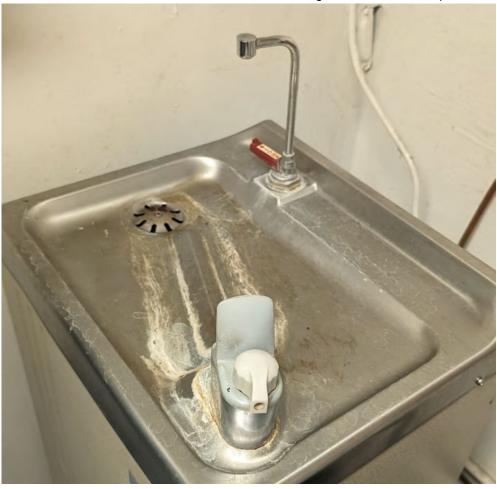
Title Observed significant scale buildup at drinking fountain

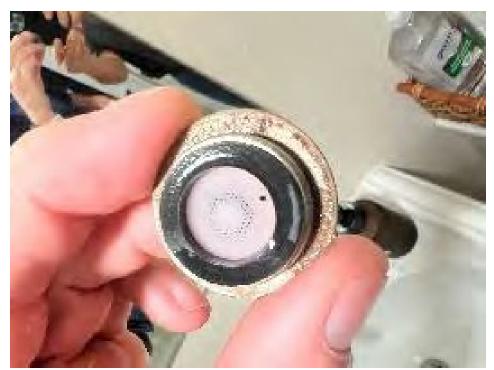
Photograph 1: Interior of bathroom faucet aerator, with a small black particle and orange colored rust on the perimeter of the aerator surface

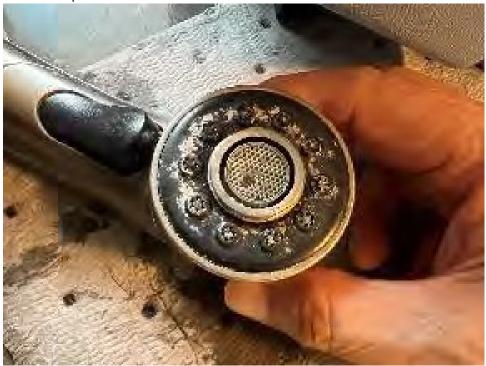
Photograph 2: Exterior of Kitchen faucet aerator, with a few small particles and scaling.

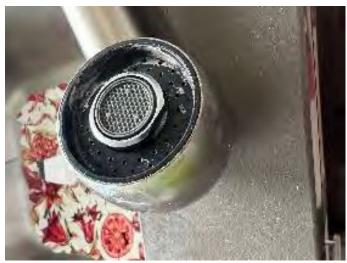
Photograph 1: Exterior of Kitchen faucet aerator. Note that there are small white particles on the exterior of the aerator.

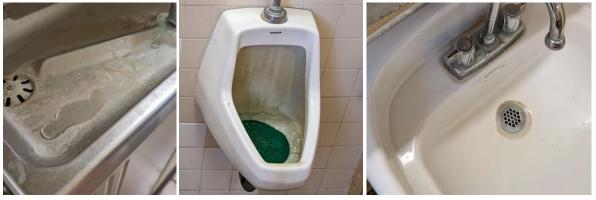
• Photographs 1, 2, and 3: Observed calcite scale buildup on all appurtenances, sinks, toilets, urinals as well as green-brown staining, presumably arising due to growth of airborne microorganisms.

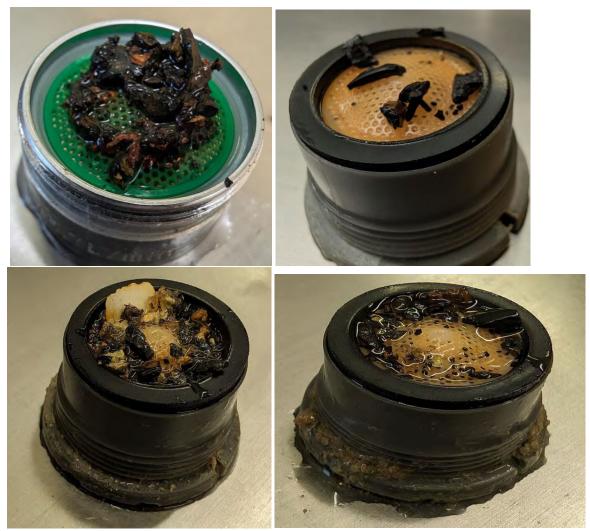
Photograph 4, 5, 6, and 7: Faucet aerator in kitchen was clean, but aerators on four faucets in the bathroom presented significant buildup of debris resembling dirt and rust. The particulate matter may be a result of the recent service line repair or could be due to interior corrosion of the water heater.

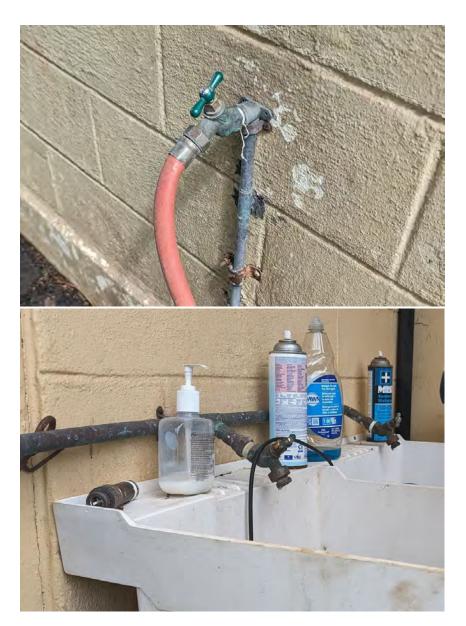
Photogarph 8 and 9: Only one of the four exterior hose bibbs had a vacuum breaker installed. The spouts of the two faucets at the outdoor utility sink are installed too low, presenting potential cross connections.

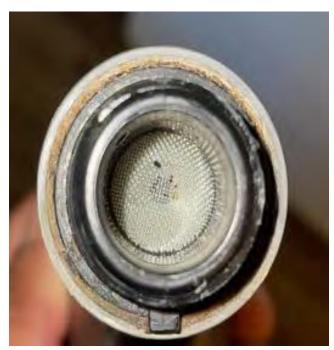
• **Figure 1.** Interior view of kitchen sink aerator. Upon visual inspection, miniscule specs of debris can be observed.

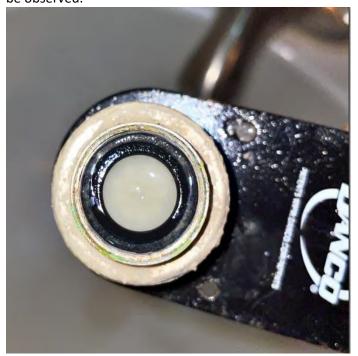
• **Figure 2.** Interior view of hallway bathroom sink aerator. Evidence of copper oxidation visualized as blue-green corrosion surrounding the gasket. The outer rim of the aerator appears to have accumulated amount of biological growth, mineral deposits, and saponification.

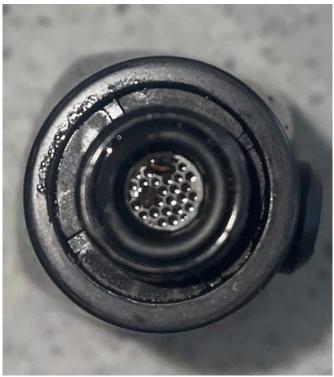
• Figure 1. Interior view of kitchen sink aerator. Upon visual inspection, miniscule specs of debris can be observed.

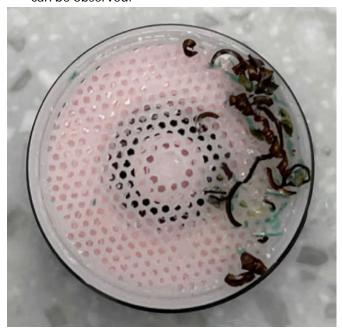
• Figure 2. Interior view of hallway bathroom sink aerator. Evidence of metal shavings were present likely as a result from recent plumbing repairs/modifications.

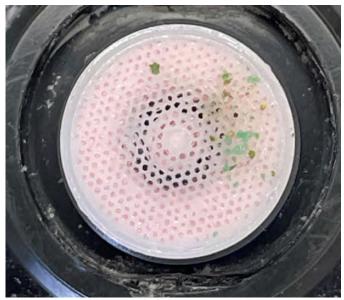
• Figure 3. Interior view of master bathroom sink aerator. The green debris appears to be the result of oxidized copper shavings likely from the recent plumbing repairs/modifications.

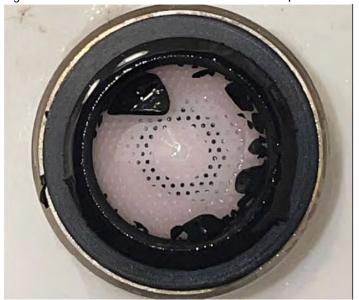
• Figure 2. Interior view of hallway bathroom sink aerator. Evidence of black and brittle debris present upon inspection.

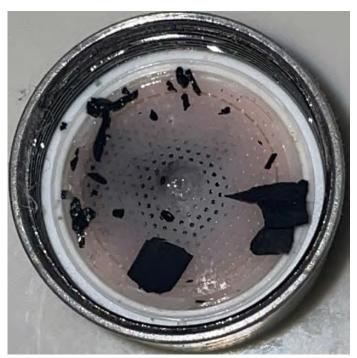
• Figure 3. Interior view of master bathroom sink aerator. Evidence of black and rubber-like debris was observed, likely associated with the recent renovations (water heater replacement, etc.).

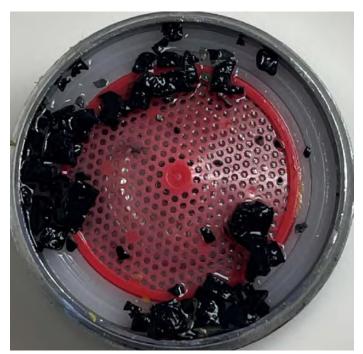
• Figure 1. Interior view of kitchen sink aerator. Upon visual inspection, flakes of debris were observed, likely the result of previous hot water heater flushing.

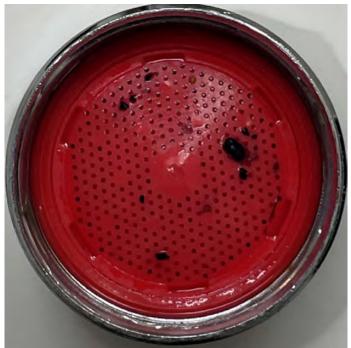
• Figure 2. Interior view of downstairs hallway bathroom sink aerator. Upon visual inspection, miniscule amounts of debris were observed.

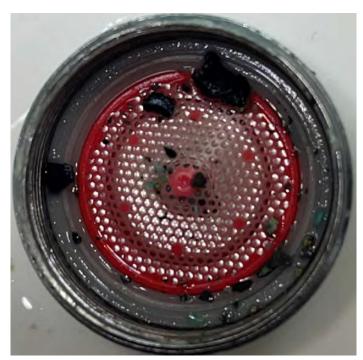
• Figure 3. Interior view of upstairs master bathroom sink aerator. Upon visual inspection, additional debris were observed.
