Drinking Water Long-Term Monitoring Comprehensive Report

JOINT BASE PEARL HARBOR-HICKAM, O'AHU HI

2025 Revision

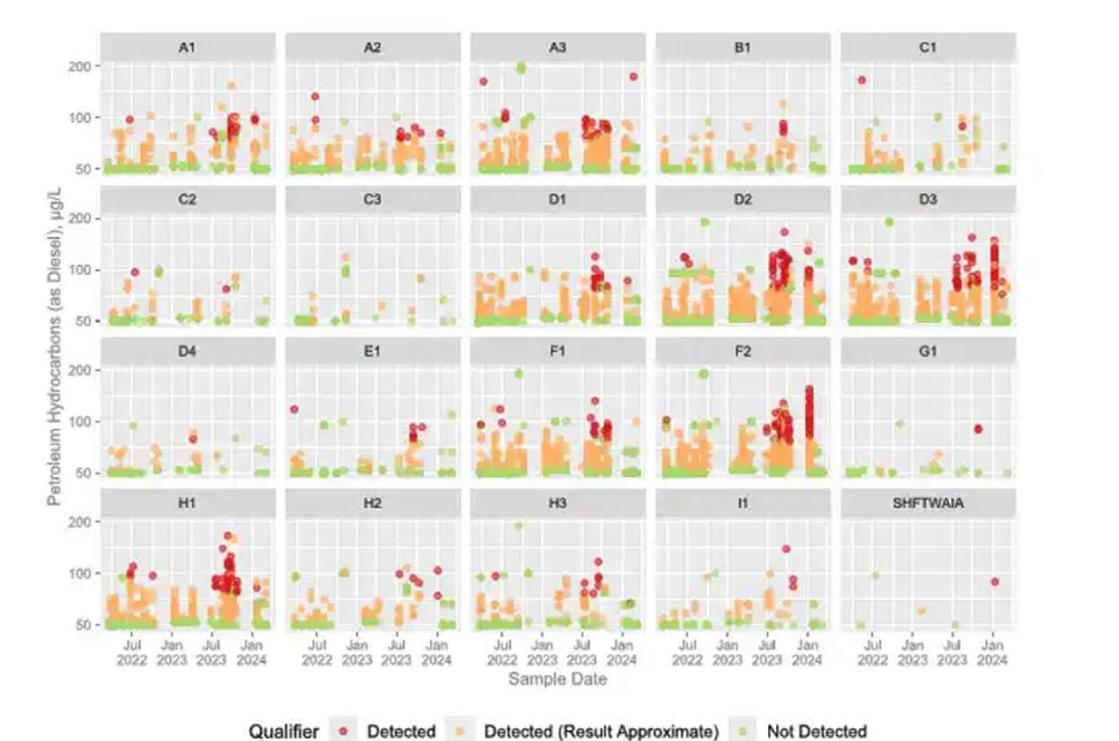
Figure 4: TPH-Diesel Detection

The zone maps in Appendix C do not show any significant clustering of TPH detections or exceedances across zones. TPH detections peaked in relative proportion during Period 6 prior to the surrogate concentration change, and significantly dipped in Period 7 after the change was incorporated.

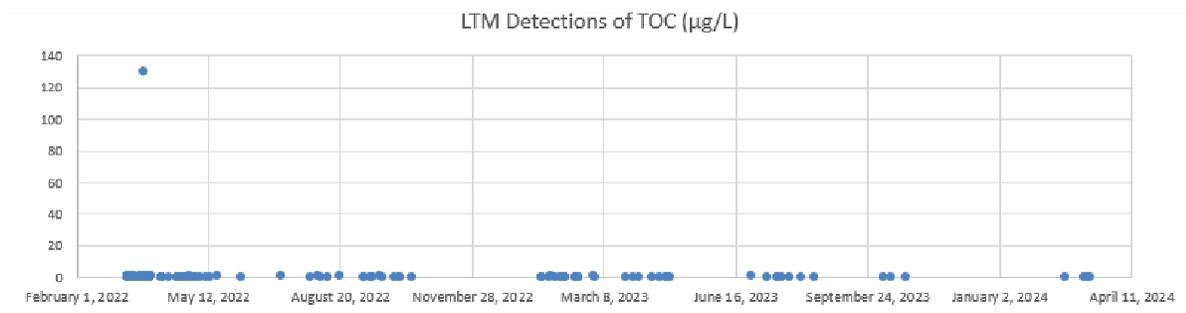
TOC detections across all LTM events were broadly low-level periodic detections, with a median detection value of 0.49 µg/L, with one exceedance in March 2022 in zone F2. The ISP for TOC is 2 µg/L. The one TOC exceedance was resampled and bracketed with four hydrant samples. TOC was not found in any of the resamples. There were two TOC exceedances initially reported in Period 7 - one in Zone H2 (8.1 ug/L) and one in Zone H3 (7.1 ug/L) – both were found to be a sampling error.

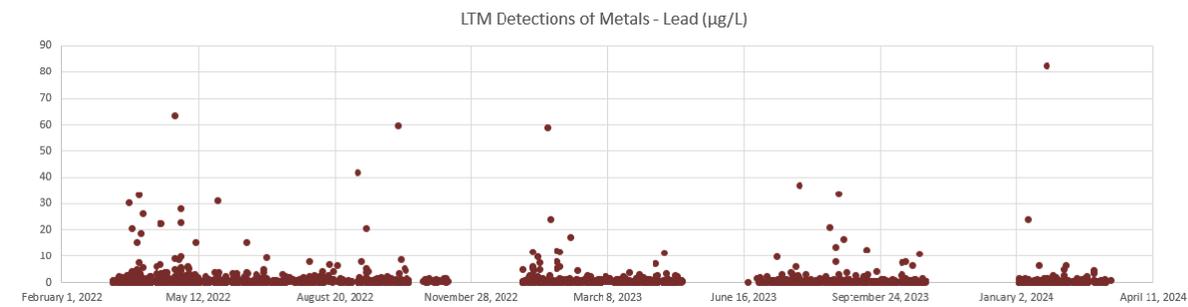
Lead: The ISP and DOH AL for lead is 15 µg/L. Detections were observed throughout all event periods. Lead detections above the ISP did not have a temporal or geographical trend. Exceedances were as follows:

- Five exceedances across five zones were observed in Period 1
- Six exceedances across three zones were observed in Period 2
- Two exceedances across two zones were observed in Period 3
- Four exceedances across three zones were observed in Period 4
- Three exceedances across three zones were observed in Period 5
- Four exceedances across three zones were observed in Period 6
- Two exceedances across two zones were observed in Period 7

All exceedances were remediated with flushing and resampling, or fixture replacement when resampling indicated a continuous localized issue in accordance with established protocols of the approved DW LTM Plan. Table 4 demonstrates that the relative lead detections were most present in zones H1 and H2; however, the proportion of exceedances amongst all zones was under 1 percent.

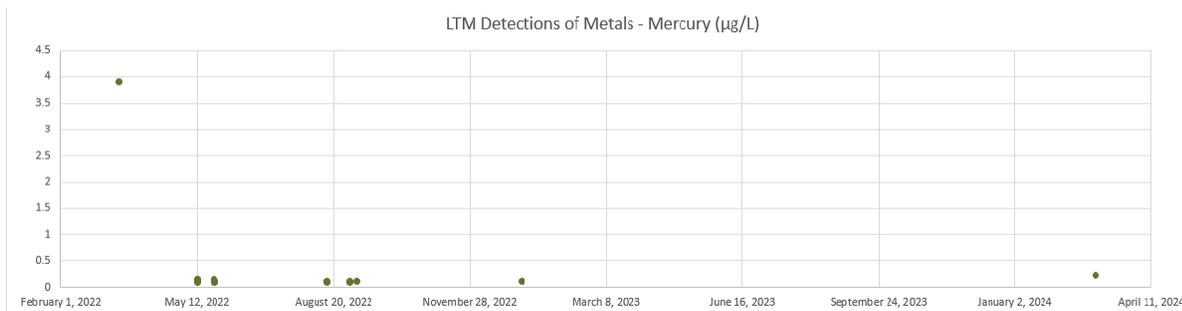
Mercury: The ISP and DOH MCL for mercury is 2 µg/L. Mercury detections across LTM were broadly low-level periodic detections, with a median detection value of 0.12 µg/L. There was one mercury exceedance in March 2022 in zone D1 at Pearl Harbor Kai Elementary School. The school was notified on the same day of the exceedance. The exceedance was remediated with fixture replacement after flushing and resampling did not eliminate the elevated detections. After fixture replacement, additional sampling confirmed mercury was no longer present. The mercury detections did not indicate a geographical or temporal trend.

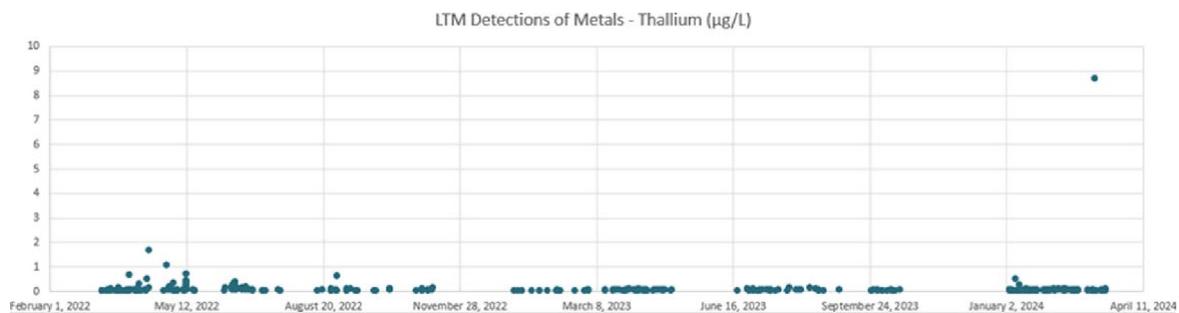
Thallium: The ISP and DOH MCL for thallium is 2 µg/L. Thallium detections across all LTM events were broadly low-level periodic detections, with a median detection value of 0.07 µg/L. There was one exceedance in March 2024 in zone F1; a hydrant detection of 8.7 ppb. The hydrant was flushed, split samples were collected and analyzed by SGS and Pace, two independent, EPA-certified laboratories. The resample result for SGS was .051 ppb while the Pace result was non-detect. The thallium detections did not indicate a geographical or temporal trend.

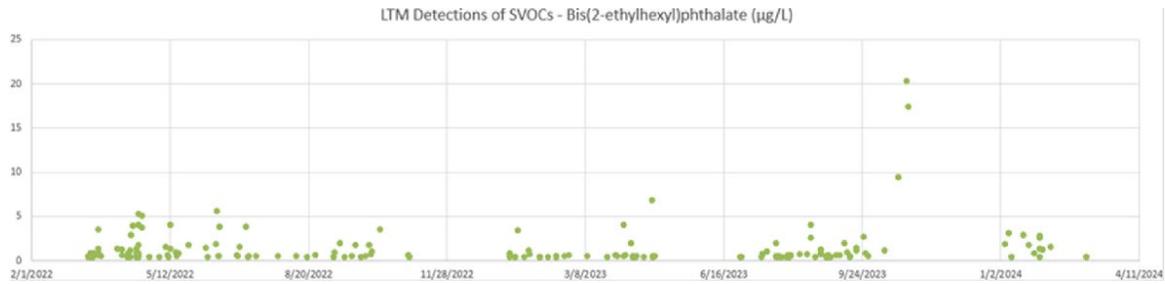
Bis(2-ethylhexyl)phthalate: The ISP and DOH MCL for bis(2-ethylhexyl)phthalate is 6 µg/L. Bis(2-ethylhexyl)phthalate detections above the ISP did not have a temporal trend. All exceedances, but not all detections, of bis(2-ethylhexyl)phthalate were observed in zone A3, as summarized in Table 5, and contributed to 0.3 percent exceedances across all LTM samples collected in that zone. Periodic detections were remediated with flushing or fixture replacement. Multiple exceedances were observed at 6224A Ibis Ave in October 2023 (Zone A3), which were associated to one home with continued elevated

concentrations. Through bracketing and resampling, the source of the contamination was determined to be the kitchen sink, which was replaced on October 28, 2023; results from the resample were below the ISP.

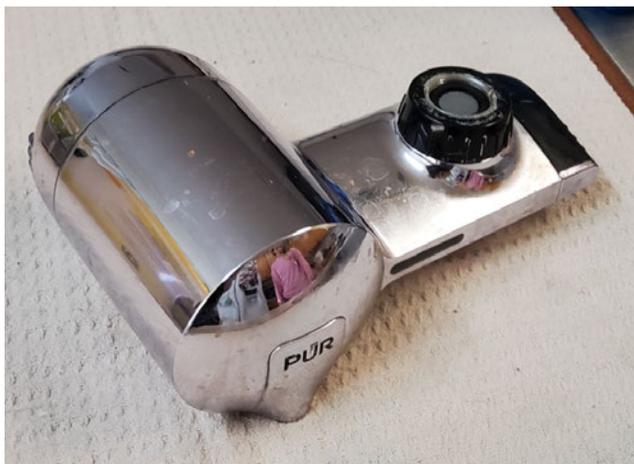
Figure 1. Kitchen Sink Filter at 2110 Schmitt Parkway.

- The resident utilizes faucet filter systems for the kitchen sink (PUR PFM400H1, Figure 1) and bathroom faucets and shower heads (Tylola2, Figure 2). The resident stated that she replaces the kitchen filter faucet carbon filters when the unit’s indicator comes on.
- No particulate matter has accumulated on the aerator screen of the kitchen sink filter. However, there was a little mineral scale built-up.
- After ensuring that the dishwasher was not in operation, and after removing the attached carbon filter, the Seabee collected a sample in a 40-mL amber-glass vial from the kitchen faucet for total petroleum hydrocarbons (TPH) analysis at the PWD laboratory.
- The Seabee also filled a clear plastic cup with water to inspect for sheen. No sheen was visible on the sample.

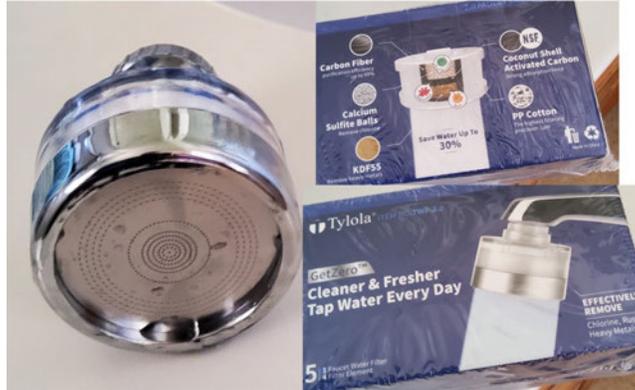
Figure 2. Bathroom Fixture Filters at 2110 Schmitt Parkway.

- Advise residents of certifications of point-of-use (POU) water treatment devices and the required maintenance.
- Review the water heater maintenance logs, ensure the tank is thoroughly flushed, and consider replacement of corroded fittings and the anode or, given its age, replace the entire appliance.
- Have the public-private venture (PPV) housing company adjust the temperature settings on the heater. To control growth of certain plumbing pathogens, the American Society of Heating, Refrigerating, and Air-Conditioning Engineers (ASHRAE) recommends a minimum water heater temperature of 120°F³.
- Advise the LTM sampling teams to adjust faucets during sampling to ensure a steady, laminar flow, where possible. Unless requested otherwise by the resident, it is suggested that the kitchen faucet be sampled.

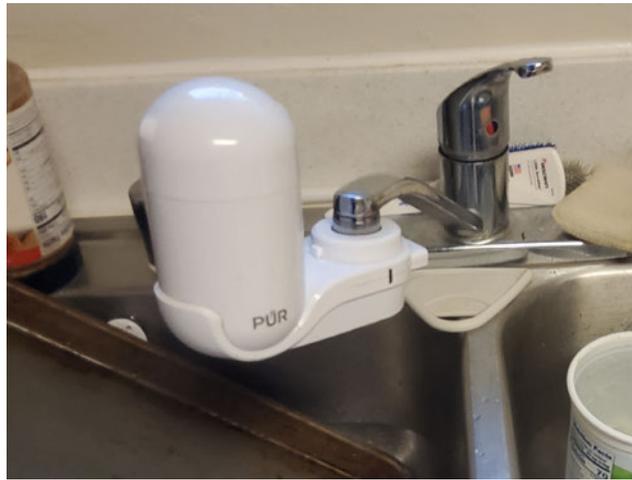
- There was a POU filter installed on the kitchen faucet (PUR FM-3333B4, Figure 5). The device has a light indicating when the filter element needs replacement.

Figure 5. Kitchen Faucet Filter at 207 Beard Avenue.

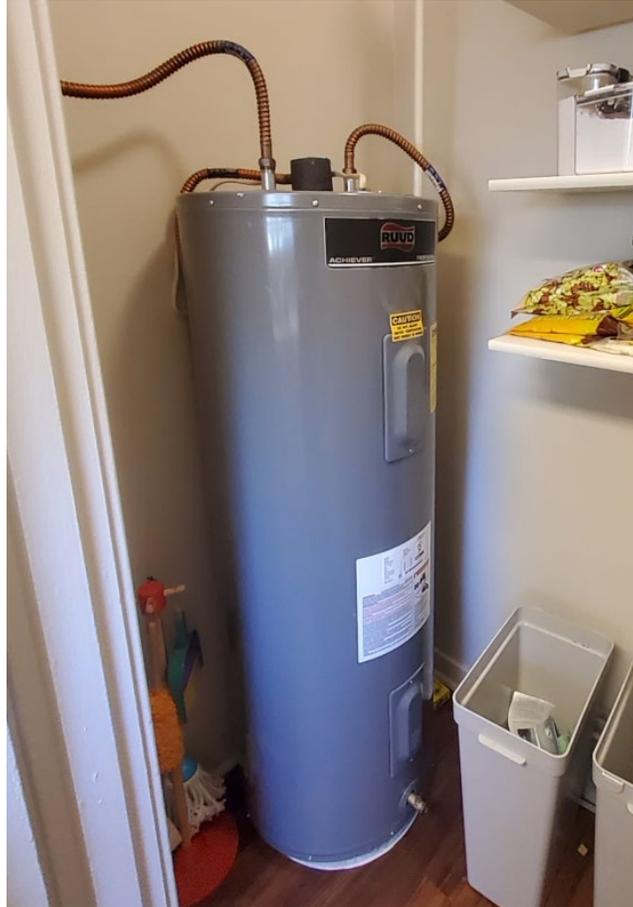
- The water heater is a 50-gallon standard electric heater (Ruud Achiever) made by the Rheem Manufacturing Company in 2018 (Figure 6), and it connected with copper piping.

Figure 6. Water Heater at 207 Beard Avenue.

- The hot water discharge piping from the water heater was not insulated.
- C. Recommendations
- To avoid loss of heat from the hot water piping, it is recommended that appropriate insulation be installed.

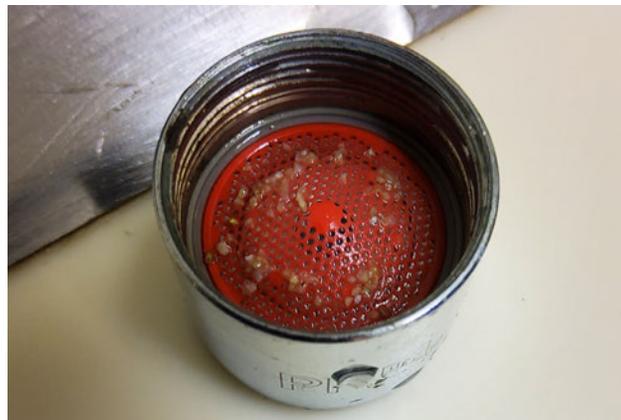
- Using a special key, the LTM team removed the aerator from the kitchen faucet. The aerator screen was clean. The inspector also removed the aerator from the faucet in the utility room adjacent to the kitchen. The aerator screen was partially clogged with sand grains (Figure 7).

Figure 7. Utility Sink Aerator Screen at 2879 Arizona Road.

- Ensure that aerator screens are cleaned periodically. Accumulation of debris can inhibit flow. Additionally, in older plumbing systems, where lead solder was used, metal shavings from repairs may accumulate on the screen, potentially resulting in elevated first-draw lead concentrations during compliance sampling.

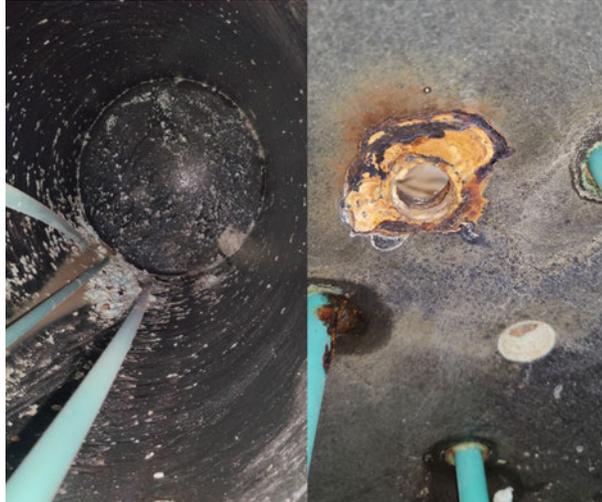
On 29 February, PW personnel removed part of the heater's insulation and cut a 6-inch by 8-inch opening in the side of the steel vessel near the top. The protective glazing on the interior side of the cutout piece appeared intact. Inspection of the interior of the tank vessel showed a large accumulation of mineral scale, similar to that observed on the heating element. The largest pieces were removed from the tank and inspected visually. The pieces consisted of the nearly completely corroded steel cable to which the anode (presumably magnesium) was attached, as well as aggregates of the same mineral scale found on the heating element (Figure 12). The interior inspection of the pressure vessel showed that, while the glazing appeared intact, the onset of severe corrosion was evident adjacent to the openings for the dip tubes and anode rod (Figure 13).

In summary, the tank appeared to be in a condition commensurate with its age and the apparent lack of maintenance. There was a considerable accumulation of sand in the tank, suggesting that it has not been flushed annually. The accumulated sand has the potential to harbor microorganisms, particularly if adequate water temperatures and/or chlorine residuals are not maintained. The anode rod was completely corroded, which is likely the reason for the onset of corrosion of the steel shell. The recommended replacement interval for anode rods is 3 to 5 years.

Figure 13. Interior Tank Bottom (left) and Top (right).

- Once drained, inspect the heating elements of the water heater for build-up of minerals; clean or replace as necessary.
 - Inspect the faucet aerators to check for signs of debris that may indicate deterioration of the heater’s anode or corrosion of the steel shell.

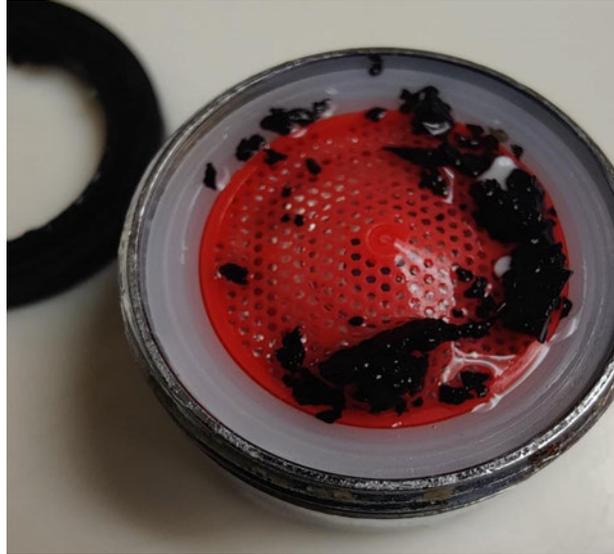
- The inspector removed the aerator from the kitchen faucet and found the screen covered with brittle, black granules (Figure 15).
- Both hot and cold water appeared clear, without bubbles, particulate matter, or sheen. The inspector noted no taste or odor. No other water quality parameters were recorded.
- The 80-gallon solar water heater is made by SunEarth, Inc. (Fontana, CA). The label was partially covered by solar loop thermostat and therefore, the manufacturing date was not legible. However, the unit appeared to be in good condition without signs of external corrosion (Figure 16).

Figure 15. Kitchen Faucet Aerator Screen at 5202 Fuqua Lane.

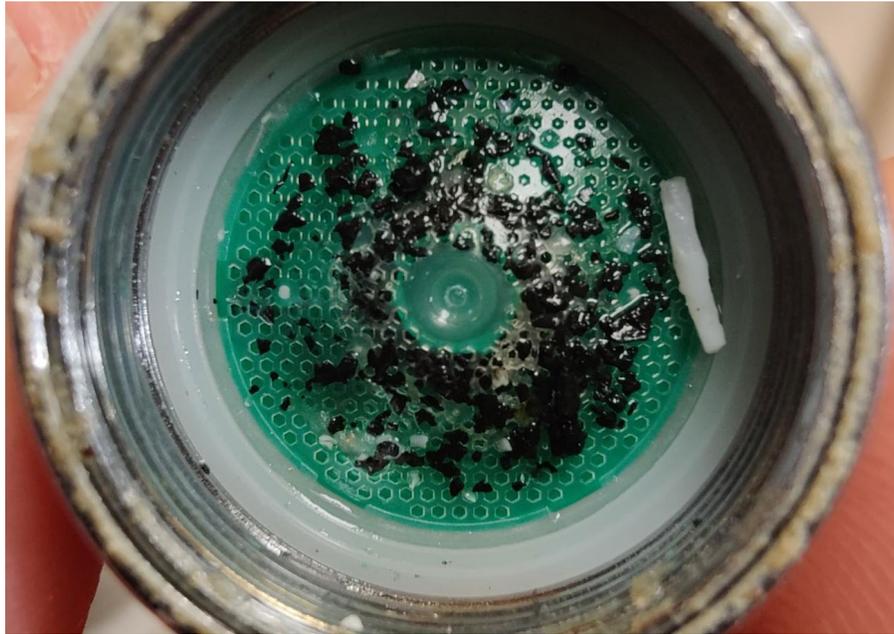
- The inspector noted black, brittle granules and a small piece of white plastic on the kitchen faucet aerator screen. The edges of the aerator housing had some mineral scale buildup (Figure 17).

Figure 17. Kitchen Faucet Aerator Screen at 1824 Porter Avenue.

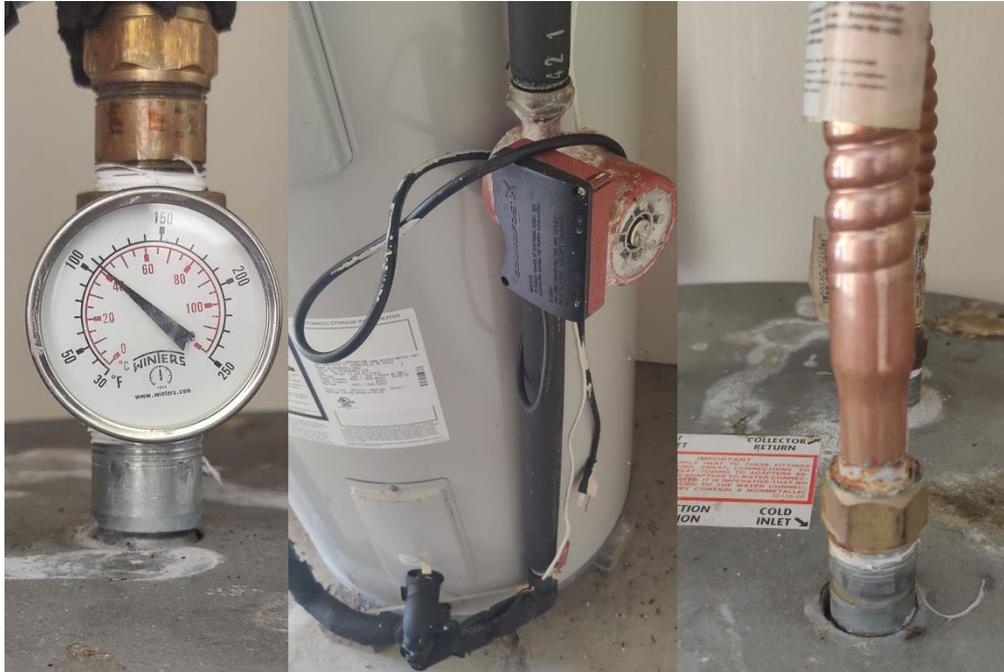
- The chlorine residuals were adequate in both cold and hot water. The hot water temperature should be 115°F or higher.
- Neither the hot nor the cold water exhibited any bubbles, particulate matter, taste, odor, or sheen.
- The 80-gallon water heater was made by the Bradford White Corporation (Middleville, MI). The inspector could not discern the manufacturing date from the heater's label. The appliance used to be tied into solar panels, but the piping and recirculation pump had been disconnected and/or valved off. The cold-water supply copper tubing appeared new. There was some external

corrosion on the heater shell and the out-of-service recirculation pump. The temperature indicator showed approximately 107°F, which is significantly below the minimum temperature recommended by ASHRAE.

Figure 18. Water Heater at 1824 Porter Avenue.

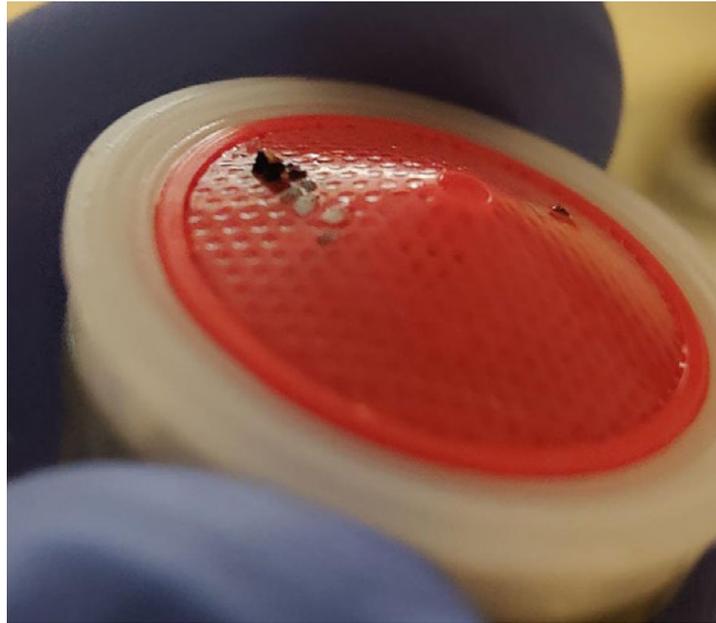
- There were no filters installed on the kitchen faucet or under the sink. The premise piping was made from copper.
- There were some small black particles and some sand grains on the kitchen faucet aerator screen (Figure 19).

Figure 19. Kitchen Faucet Aerator Screen at 926 Huttenberg Court.

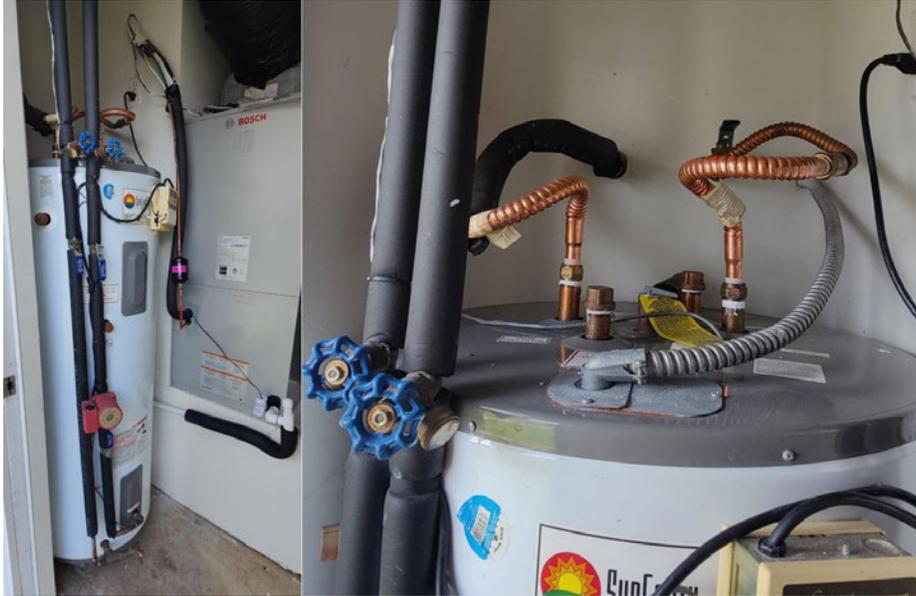
- The chlorine residuals were adequate in both hot and cold water. The hot water temperature at the outlet was below 115°F.
- The 80-gallon solar water heater was manufactured by SunEarth, Inc. in 2014. The cold-water supply and hot water discharge tubing seemed new, and the heater appeared to be in good condition. The new hot water discharge tubing was not insulated. There was no temperature gauge installed.

Figure 20. Water Heater at 926 Huttenberg Court.

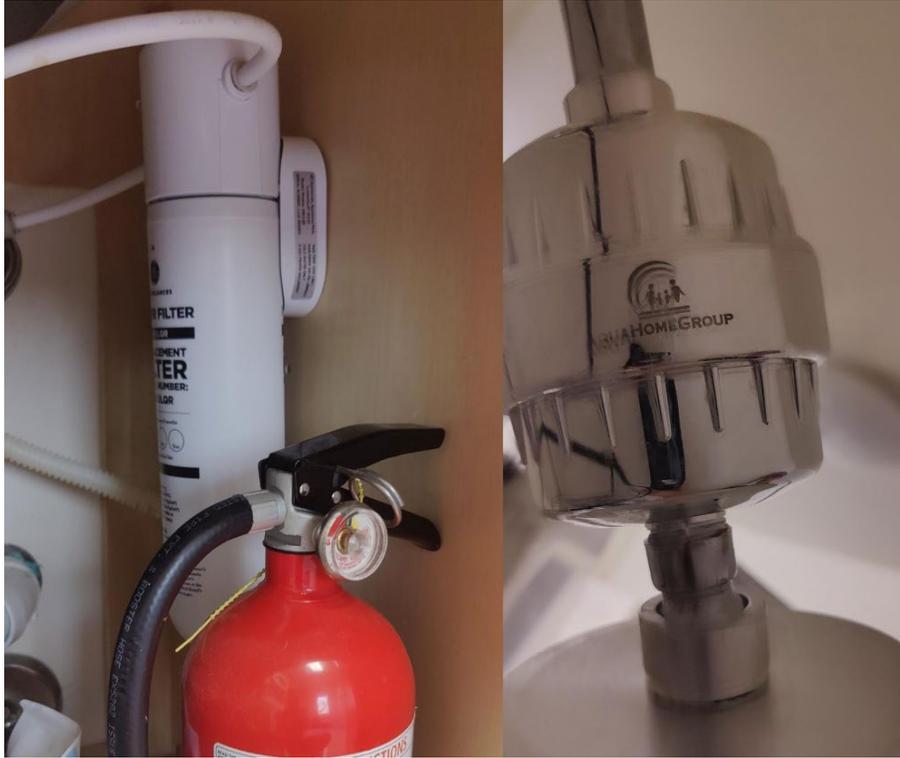
- The cold-water chlorine residual was measured at the upstairs bathroom. While the chlorine residuals are good, the hot water temperature is too low. The resident stated that a ticket was submitted to PPV housing in December 2023 to get the issue resolved.
- There is a full-flow water filter installed on the cold-water line under the kitchen sink (GE Appliances GXULQ7, Figure 21).
- There is a full flow shower filter installed in the upstairs bathroom (Aqua Home Group, Figure 21). The resident stated that the filter is exchanged every 3 months. The product vendor was not found in the NSF database.
- The pressure appeared low at all outlets. No pressure regulator was found at the water supply line.

Figure 21. Kitchen and Shower Filters at 928 Ohana Nui Circle.

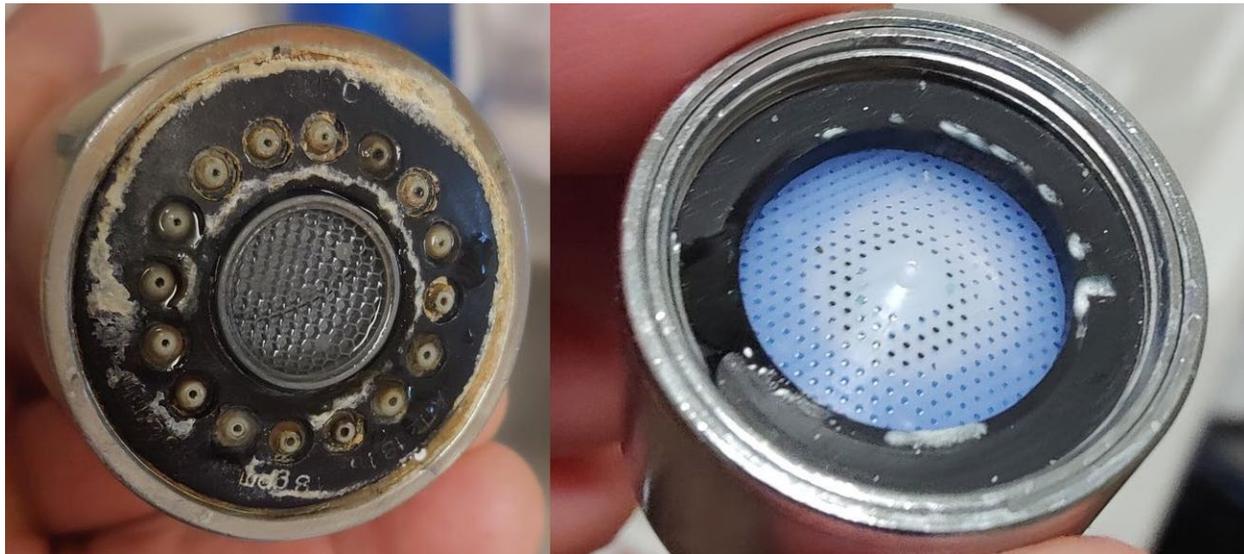
- There were outside deposits on the kitchen faucet aerator. The upstairs bathroom faucet aerator was clean, although there is some white residue on the gasket (Figure 22).

Figure 22. Kitchen Faucet Outlet and Bathroom Faucet Aerator at 928 Ohana Nui Circle.

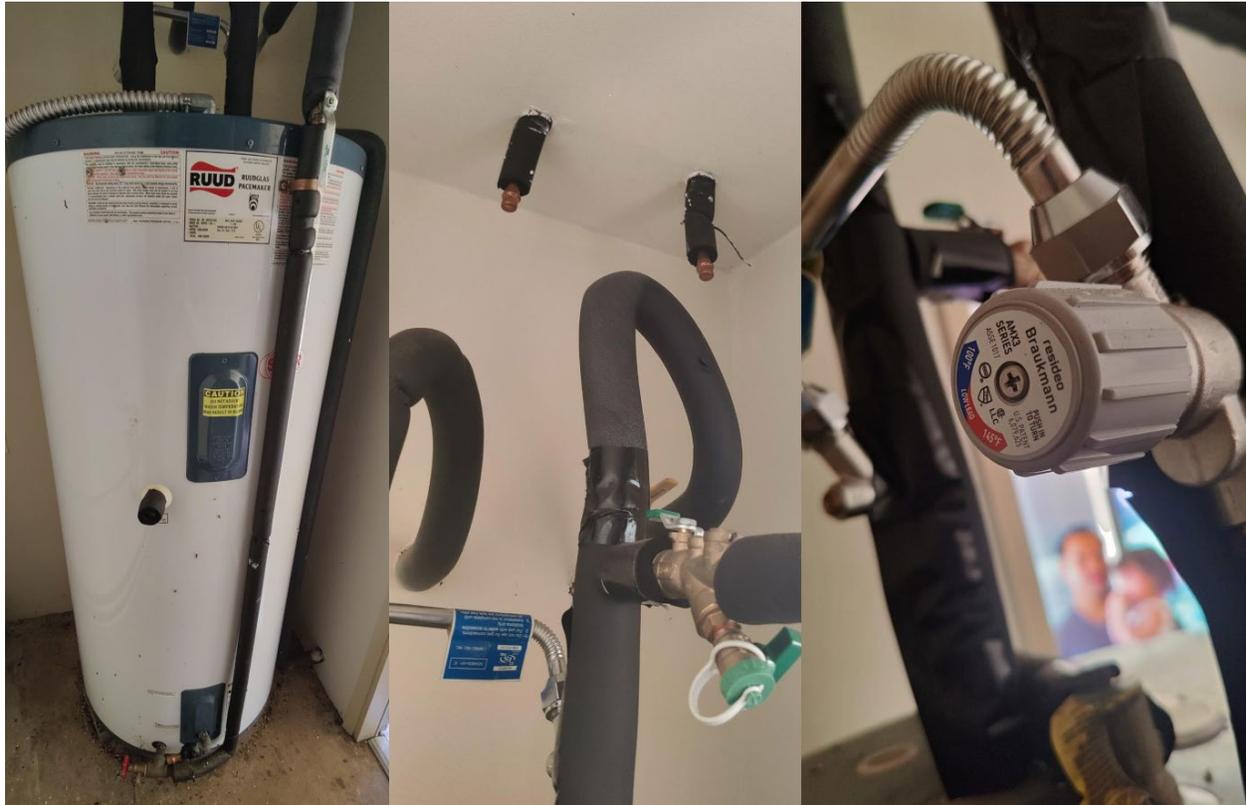
- The 120-gallon capacity water heater was manufactured in 2007, and it did not show any signs of external corrosion. The water heater did not appear to be connected to the solar panels on the roof. There was no thermostat and no recirculation pump. There was a tempering valve installed between the cold and hot water lines (Figure 23).

Figure 23. Water Heater at 928 Ohana Nui Circle.

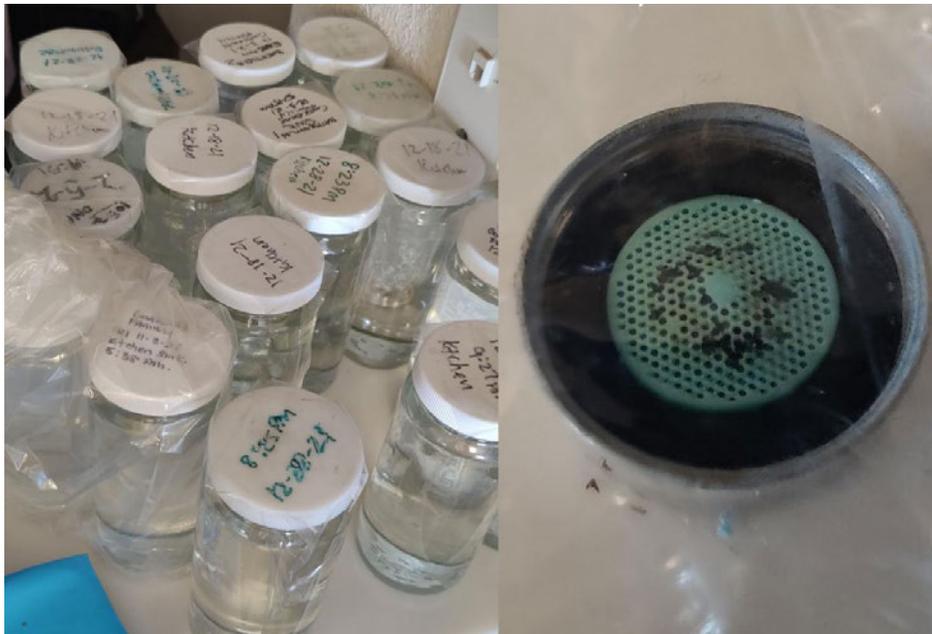
- The resident showed the inspector several glass jars that were filled with water in December of 2021. The resident also presented an old aerator in a plastic bag. It had small black specks on the screen (Figure 24).

Figure 24. Collected Water and Old Kitchen Aerator Screen at 1057 Ohana Nui Circle.

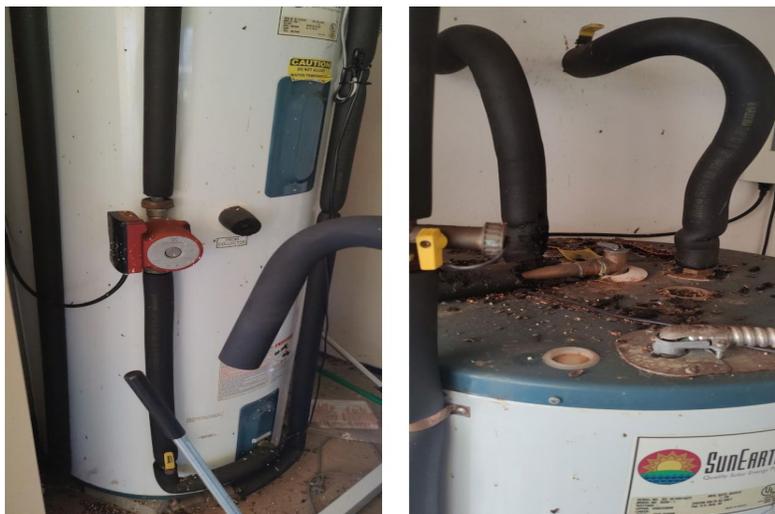
- The high hot water temperature may accelerate chlorine decay, explaining the low residual measured in the sample. The hot water had a milky appearance due to bubbles that dissipated within one minute. There was no discoloration, particles, or sheen.
- The 80-gallon water heater was made by SunEarth in 2010 (Figure 26). The heater appeared to be in fair condition. There was plant debris on top of the heater.

Figure 26. Solar Water Heater at 1057 Ohana Nui Circle.

- PPV plumbing personnel should ensure that the water heater is properly maintained. Given its age, it may need replacement.
- PPV plumbing personnel should also investigate the black stains in the toilet bowl, which might originate from the disintegration of an old gasket.

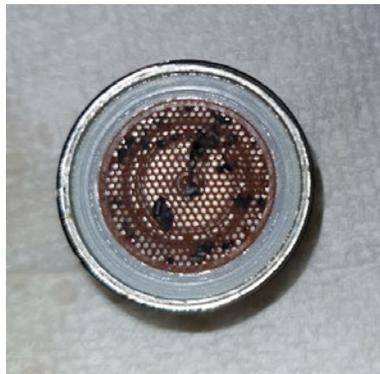
- The kitchen faucet aerator had black particles retained on screen as noted below.

Figure 27. Kitchen Faucet Aerator

- Construction was observed on an adjacent road (Tennessee Road), where high-density polyethylene (HDPE) service lines were being replaced with copper piping. HDPE shavings have the same appearance as the particle retained on the screen.

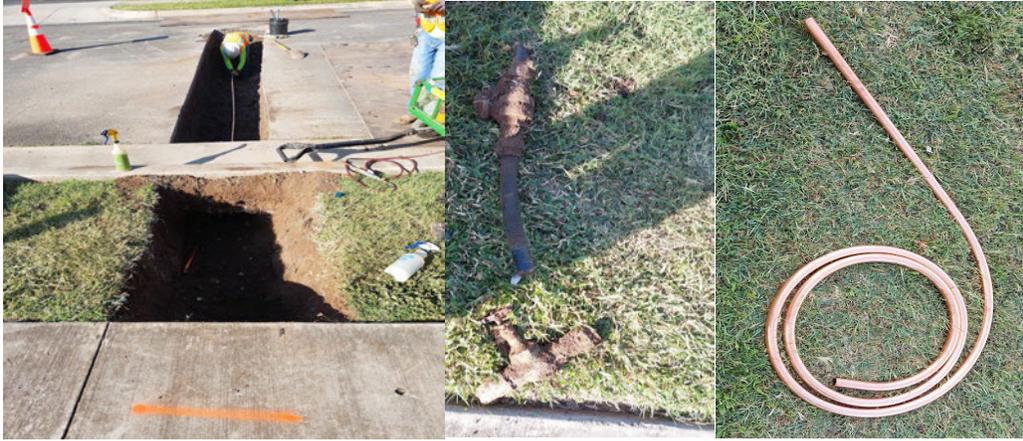
Figure 28. Service line replacement on Tennessee Street.

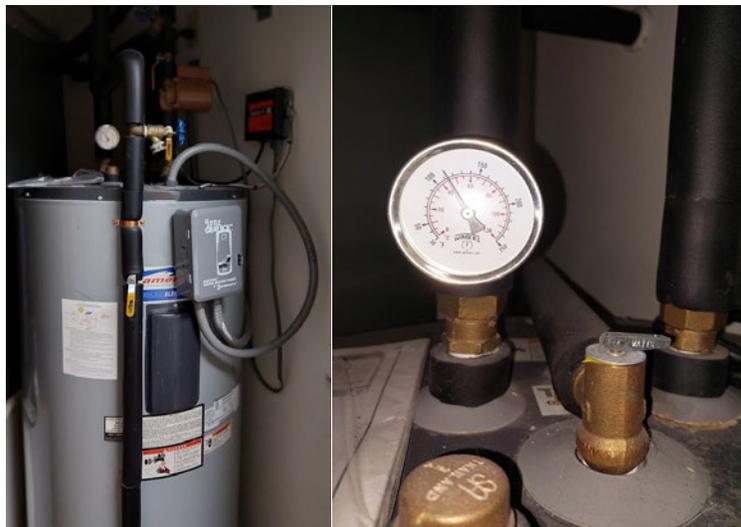
- The residence receives solar heated hot water from an 80-gallon unit manufactured by American Water Heaters.
- The hot water temperature measured at the outlet of the heater was 116°F.

Figure 31. Hot Water Heater

- The cold-water feed too and hot water discharge from the water heater were insulated.

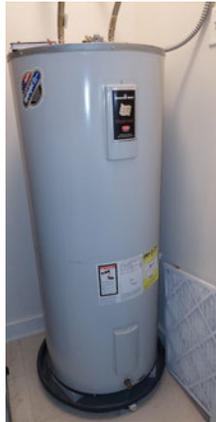
- The residence had a conventional 80-gallon electric hot water heater.

Figure 33. Hot Water Heater

- No information was listed for the date of manufacturer. However, based on the overall appearance, the unit was installed approximately ten to fifteen years ago.
- Based on the temperature recorded in the kitchen sink, the hot water heater appeared to be set and operating normally. However, no insulation on the cold or hot water piping was observed.

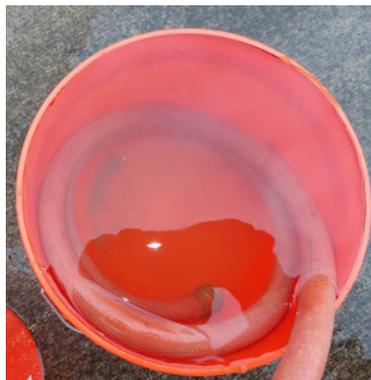
- The first draw of water exiting the water heater was clear and remained so throughout the entire drain/flush exercise.
- The discharge hose from the water heater was directed into a 5-gallon opaque polyethylene cylindrical container. Some light solids did appear to settle on the bottom of the container up to and including the 2nd Aliquot as shown below.

Figure 34. Solids in Bottom of Container

- After the second aliquot, little, if any, solid deposition was observed.
- Solids were decanted from the container and observed to be silty sand.
- Solids were collected, transferred to a glass container, and sent to the RRT laboratory for TPH analysis.
- Resident was apprised of the results.

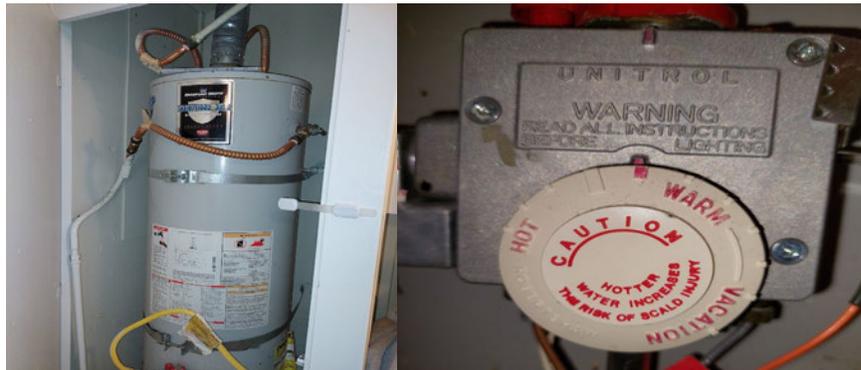
- The LTM team and RRT team sampled water in accordance with the approved sampling plans.
- The 40-gallon water heater was manufactured by Bradford White Corporation and appeared in good condition.

Figure 35. Hot Water Heater

- No insulation was observed on the cold or hot water piping.
- C. Recommendations**
- Follow up with test results, when available.
 - To avoid loss of heat from the hot water piping, it is recommended that appropriate insulation be installed.

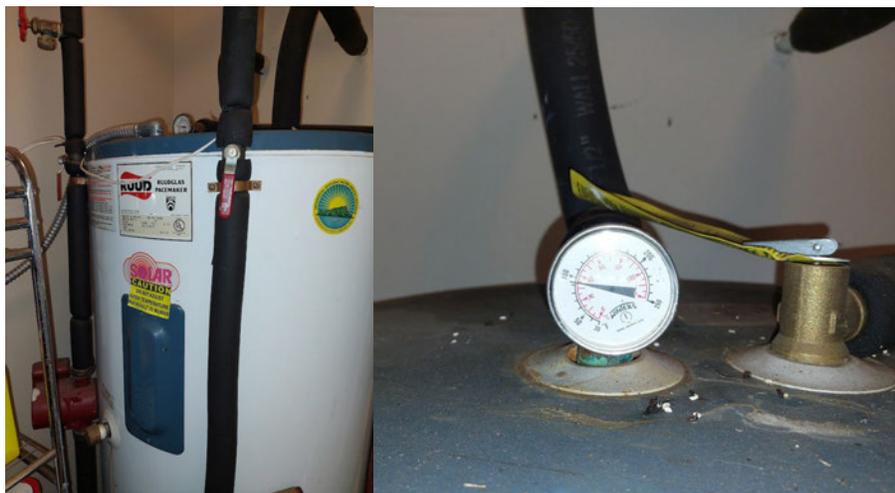
- The residence receives solar heated hot water from an 80-gallon unit manufactured by RUUD Division, Rheem Manufacturing Company in May 2006.
- The hot water temperature measured at the outlet of the heater was 96°F.

Figure 36. Hot Water Heater

- Hot water piping adjacent to the water heater was insulated, as shown in photograph above.

- Recommendations
 - The hot water heater temperature at the unit measured 96°F, which is well below the recommended level of 120°F. This may be contributing to odors in hot water.
 - Replace cartridge filters every six months.
 - Follow up with test results, when available.

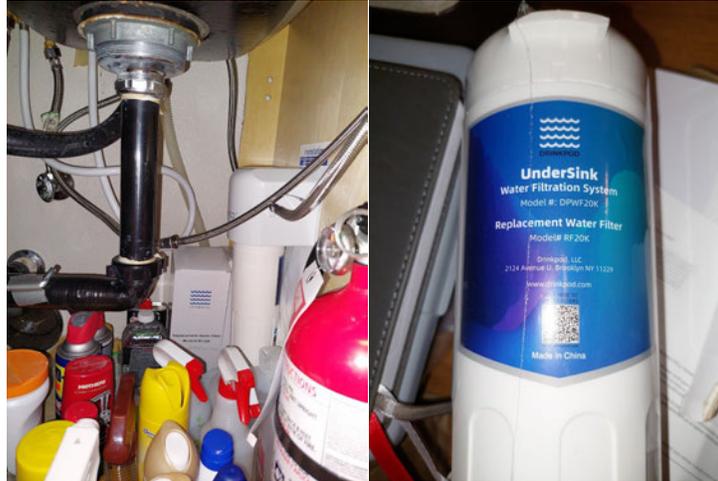
-
- Odors were detected in the bathroom sink. Faint in cold, pronounced in hot, (earthy musty), which resident articulates as a chemical odor.
 - Because of detecting odor events, customers installed GAC filters at the kitchen sink and at the master bath shower. They have been in place for no more than three months.

Figure 37. GAC Filters on Kitchen Sink and Shower

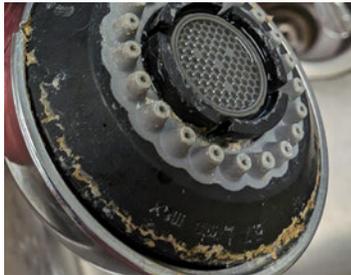
- Observed scale buildup on kitchen faucet spout. Should be cleaned after soaking in vinegar/water solution to avoid attachment of bacteria.

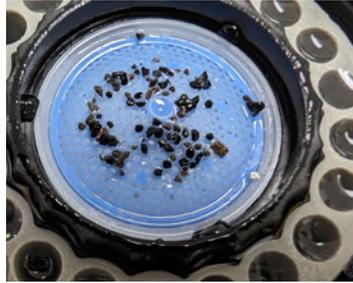
-
- Black and brown mineral particles found in kitchen faucet aerator. They may originate from debris entering the water pipes during repairs. Recommended occasional checking/cleaning to ensure faucet flow capacity is not impaired.

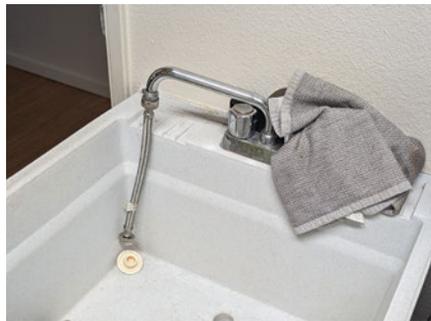
- The hose attached to the spout in the slop sink in the utility room presents a potential cross connection.

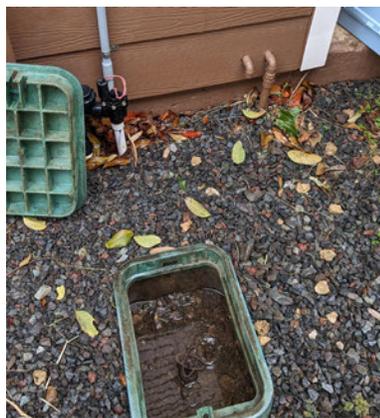
- A pipe, branching off from the supply to the heater, appears to be routed to the irrigation system without backflow prevention.

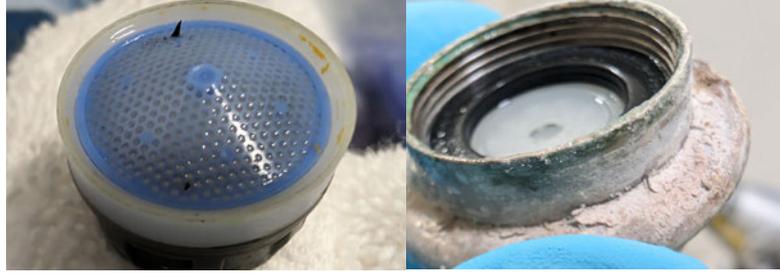
- Observed heavy calcite scale buildup on all outlets.
- Observed two small black particles on kitchen faucet aerator. The bathroom aerator was clean. Housing showed heavy external scale and minor brass corrosion.

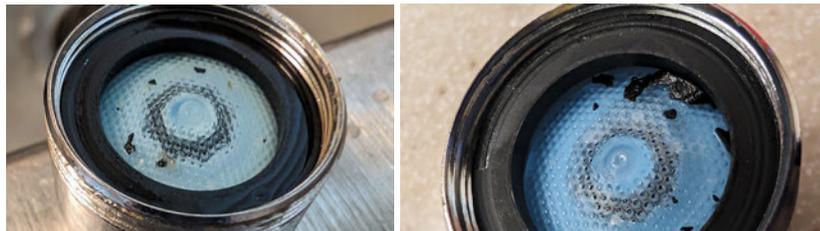
- There were several small black particles and a sand grain on the kitchen faucet aerator screen. A piece of rubber was found in the aerator of one of the upstairs guest bathroom faucets. The other aerators were clean.

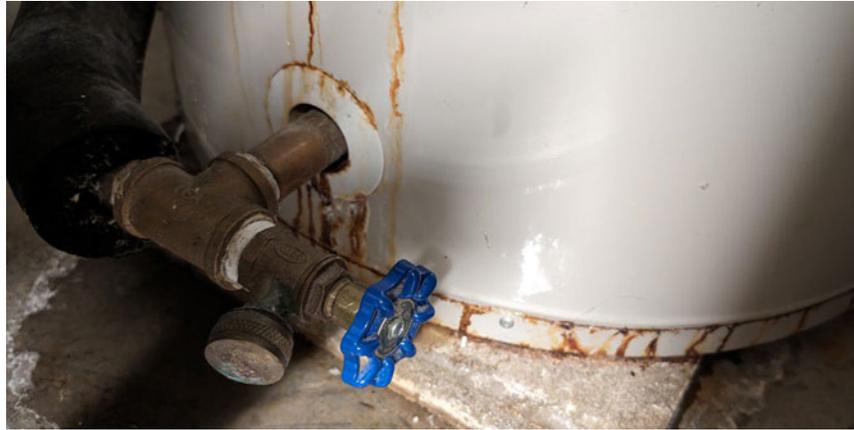
- The electric water heater was made by AO Smith. The manufacturing date is not known (2004 according to serial number). The heater is no longer connected to solar roof panels but has recently been plumbed to receive waste heat from the adjacent air conditioning unit. The pipe material is copper. A thermostatic mixing valve is installed between the cold supply and hot water line.
- Unit showed signs of past leaks and external corrosion at bottom of tank.

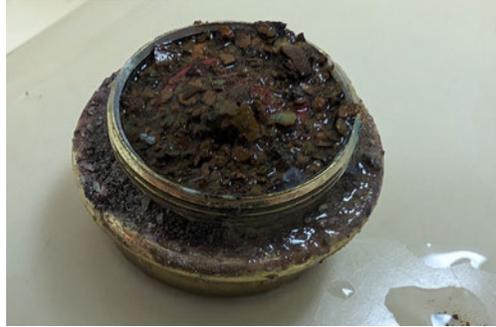
- There was a massive accumulation of rust and mineral particles on the bathroom faucet aerator. Advised tenant to have aerator replaced.

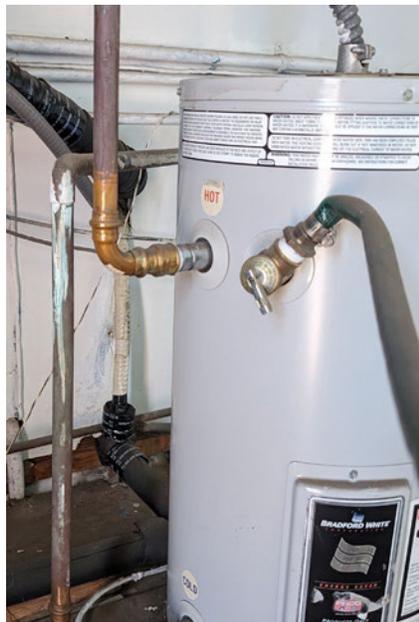
- The 12-gallon electric water heater is located in the space above the bathroom, and it was manufactured in 2012. There was a kinked garden hose attached to the pressure relief valve, which pointed upwards, creating a considerable scalding hazard.

-
- Recommend follow-up visit to test field parameters (pH, chlorine residual, etc.)
 - Advise facilities maintenance of code compliance for water heater pressure relief discharge pipe.
 - No additional actions required.

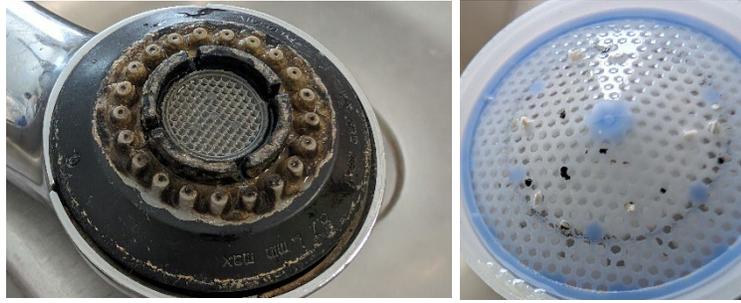
- Hot Temp 117 °F
- No sheen, particles, discoloration, or cloudiness observed in hot or cold water.
- Observed scale buildup on kitchen sink spray nozzles. There were small black and white mineral particles on the aerator screen. Some small particles were also observed on the aerator screen in one bathroom sink. Advised the resident to have aerators replaced.

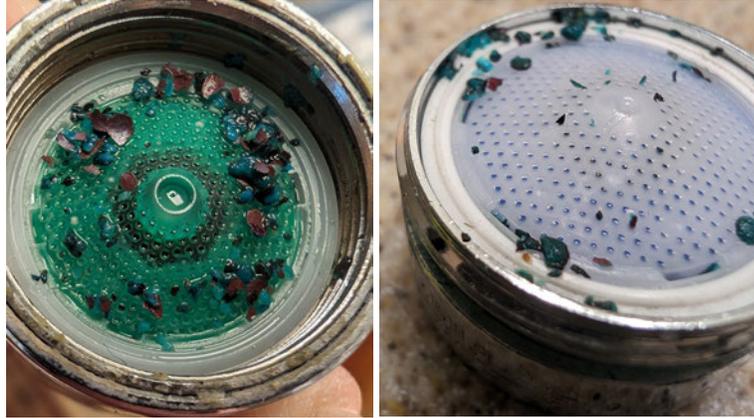
- No sheen, particles, discoloration, or cloudiness observed in hot or cold water. No unusual taste or odor.
- Faucet aerator screens in kitchen and in downstairs bathroom had accumulated some mineral particles, which, based on appearance, could originate from water heater corrosion and anode deterioration.

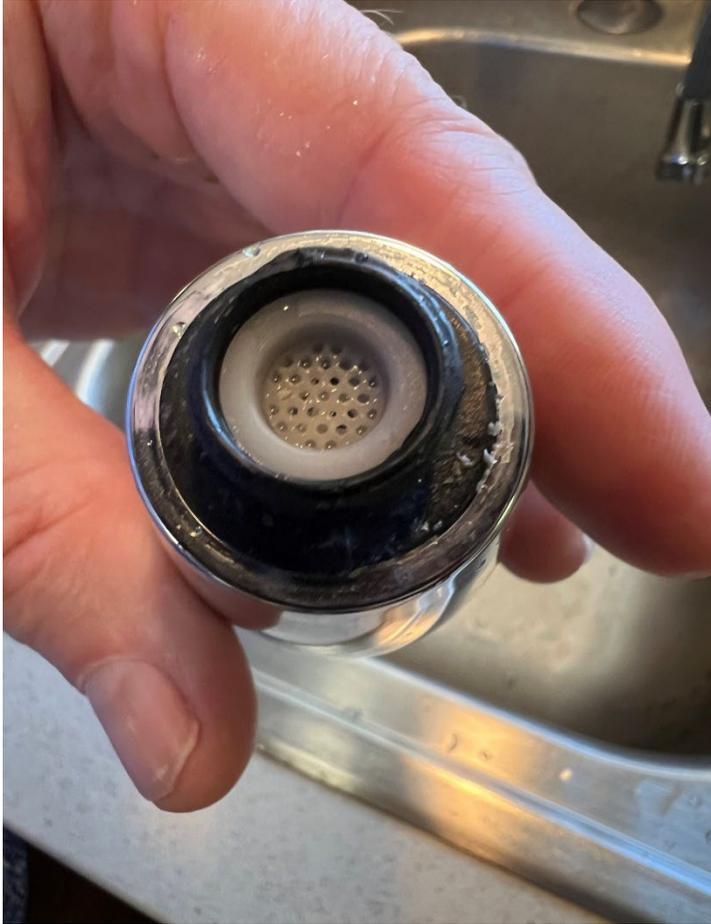
- Faucet aerator screens in kitchen and restrooms were free of any mineral particles.

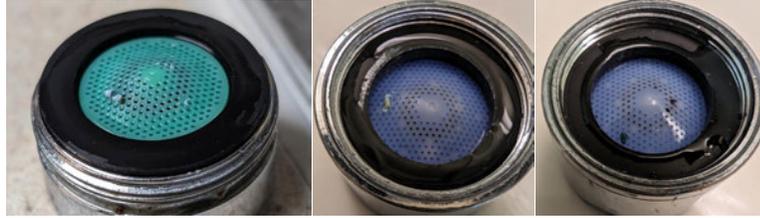
- Cold Temp 74 °F
 - Hot Temp 126 °F (Kitchen sink)
- No sheen, particles, discoloration, or cloudiness observed in hot or cold water.
- Faucet aerators in kitchen and upstairs bathrooms each showed one or two small mineral particles with a light green to dark blue hue, presumed to be copper minerals.

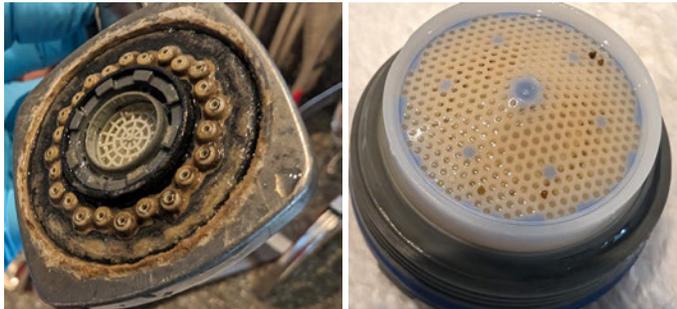
- Cold Temp 79 °F
 - Hot Temp 114 °F
- No sheen, particles, discoloration, or cloudiness observed in hot or cold water.
- Observed scale buildup on faucets and appurtenances. The kitchen faucet aerator was clean – there were a few small mineral particles visible, which appeared to be sand grains. Aerators in bathrooms could not be easily removed due to scale built-up. Advised residents to have them replaced.

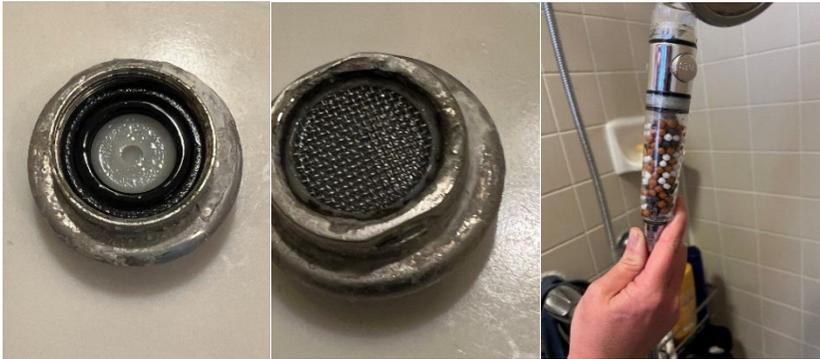
-
- Observed little scale buildup on faucets. The kitchen faucet aerator was not able to be removed. The master bedroom aerator was clean with scale deposits on the exterior of the faucet.

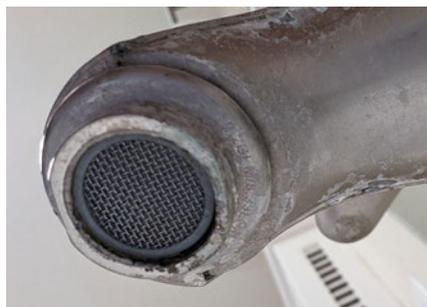
- No sheen, particles, discoloration, or cloudiness observed in hot or cold water.
- No taste or odor detected in hot or cold water.
- Faucet aerators were clean. Calcite built-up was observed at all outlets.

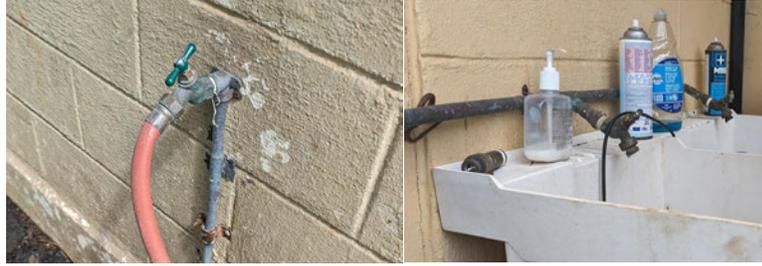
- Only one of the four exterior hose bibbs had a vacuum breaker installed. The spouts of the two faucets at the outdoor utility sink are installed too low, presenting potential cross connections.
