Pearl Harbor-Hickam-Kalaeloa Restoration Advisory Board Meeting
January 14, 2026
6 – 8 pm
Proposed Agenda

Pearl Harbor-Hickam-Kalaheo Restoration Advisory Board Meeting

**Remedial Action Update
Former Naval Air Station Barbers Point
Sanitary Landfill
Kalaeloa, Oahu, Hawaii**

**Red Hill Facility
Per- and Polyfluoroalkyl Substances (PFAS)
Remedial Investigation Update
Joint Base Pearl Harbor-Hickam,
Oahu, Hawaii**

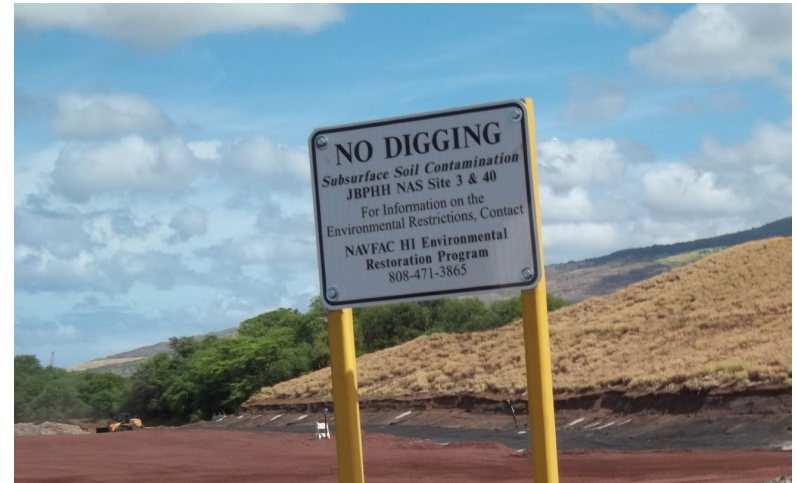
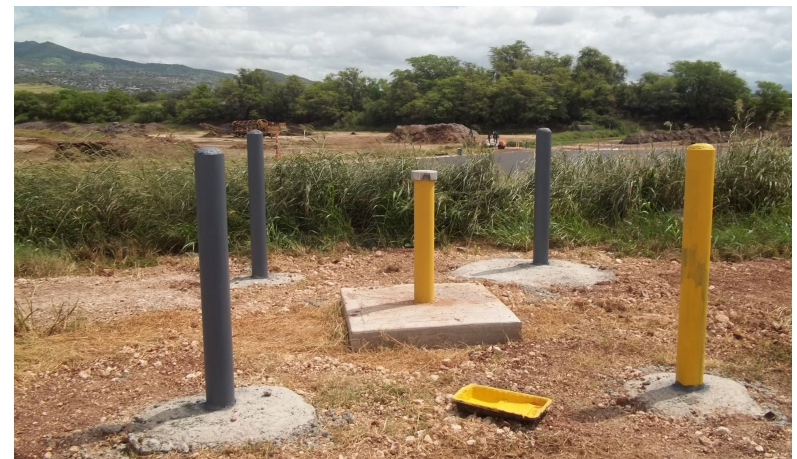
Remedial Design – LUCs and LTMM

- Land Use Controls
 - Restrict site use and perform periodic site inspections
- Warning Signs
 - “No Digging, Subsurface Soil Contamination”
 - Contact information
- Groundwater Monitoring Wells
 - 8 total wells
- Landfill Gas Probes
 - 6 total probes

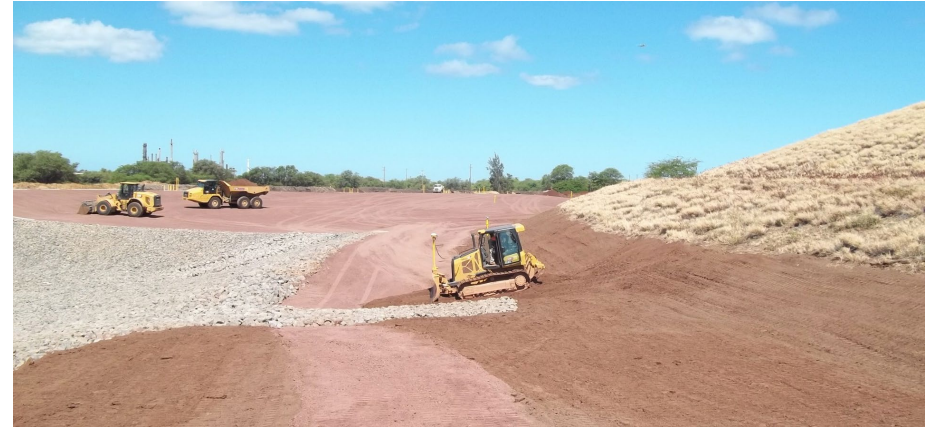
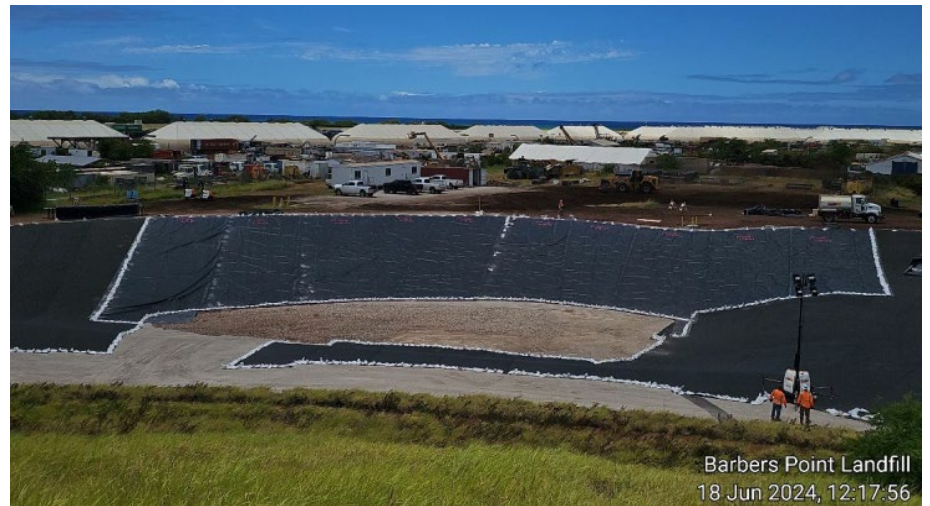
Remedial Action Construction

- **Activities Included:**
 - Regrading and landfill surface compaction
 - Foundation layer and landfill gas collection system placement
 - Installed:
 - Impermeable landfill cover and landfill gas vents
 - Groundwater monitoring wells and landfill gas monitoring probes
 - Warning signs
 - Site restoration and soil cap
- **Remedial Action Completed August 2024**
- **Remedial Verification Report completed January 2026**
- **Remedial Action Completion Report in Progress**
